Republic of Lebanon - Council for Development and Reconstruction

Road and Employment Project (REP)

Environmental and Social Management Plan (ESMP) Report
Final

LOT 2: Caza of Zahle

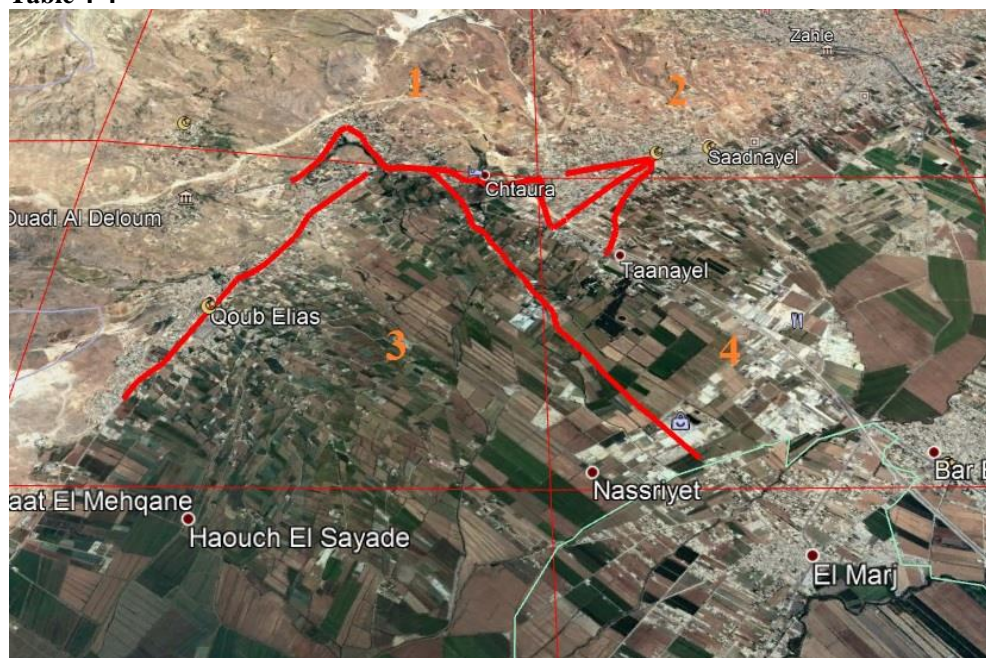
Figure 4-1 Ambient Air quality cells for Zahle R3a and R3c (spatial resolution of 5km) – values shown in Table 4-4

Table 4-4 Ambient air quality in $\mu\text{g}/\text{m}^3$ for Zahle R3a and R3c (roads fall in cells 1, 2, 3, and 4) – refer to Figure 4-1

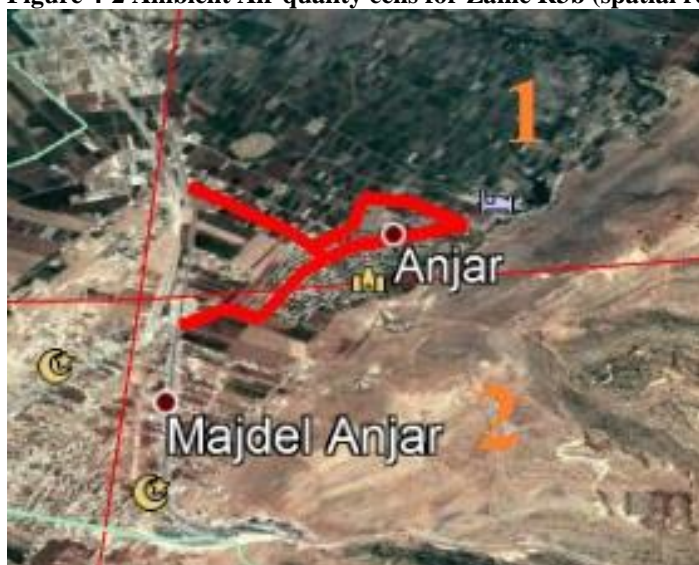
Figure 4-2 Ambient Air quality cells for Zahle R3b (spatial resolution of 5km) – values shown in Table 4-5

Table 4-5 Ambient air quality in $\mu\text{g}/\text{m}^3$ for Zahle R3b (road falls in cells 1 and 2) – refer to Figure 4-2

Cell ID	NO ₂	O ₃	PM ₁₀	PM _{2.5}	SO ₂	CO
1	20.102	75.077	17.288	15.252	10.378	404.524
2	13.618	82.089	16.473	14.423	8.719	307.149
Lebanese Ambient Air Quality standards, Decision 52/1	100	100	80	-	80	10,000
NAAQS, EPA	107.6	147.7	150	35	84.6	11,070
Exposure Duration	1 year	8 hours	24 hours	24 hours	1 year	8 hours

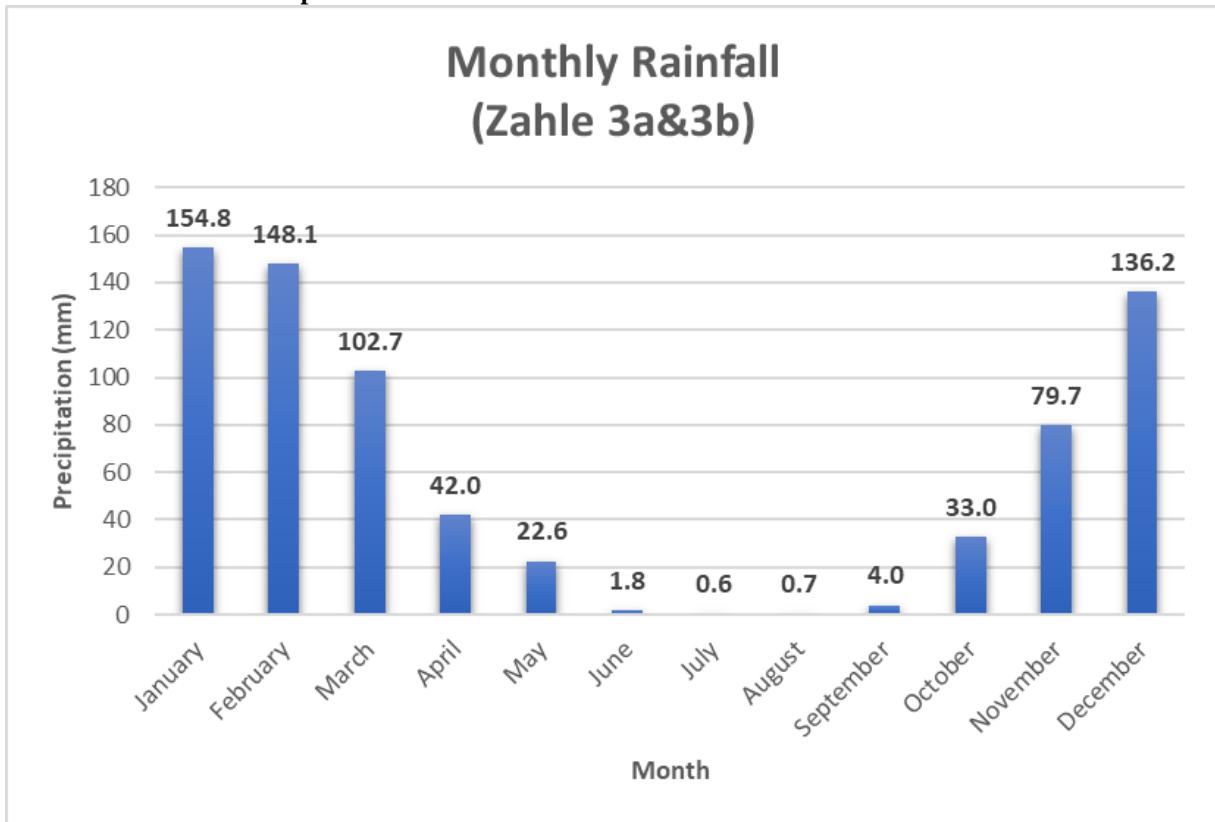
**Figure J Precipitations values along Zahle 3a&3b alignments (period extending between 1996-2018)
CHIRPS satellite 4.5 km spatial resolution**

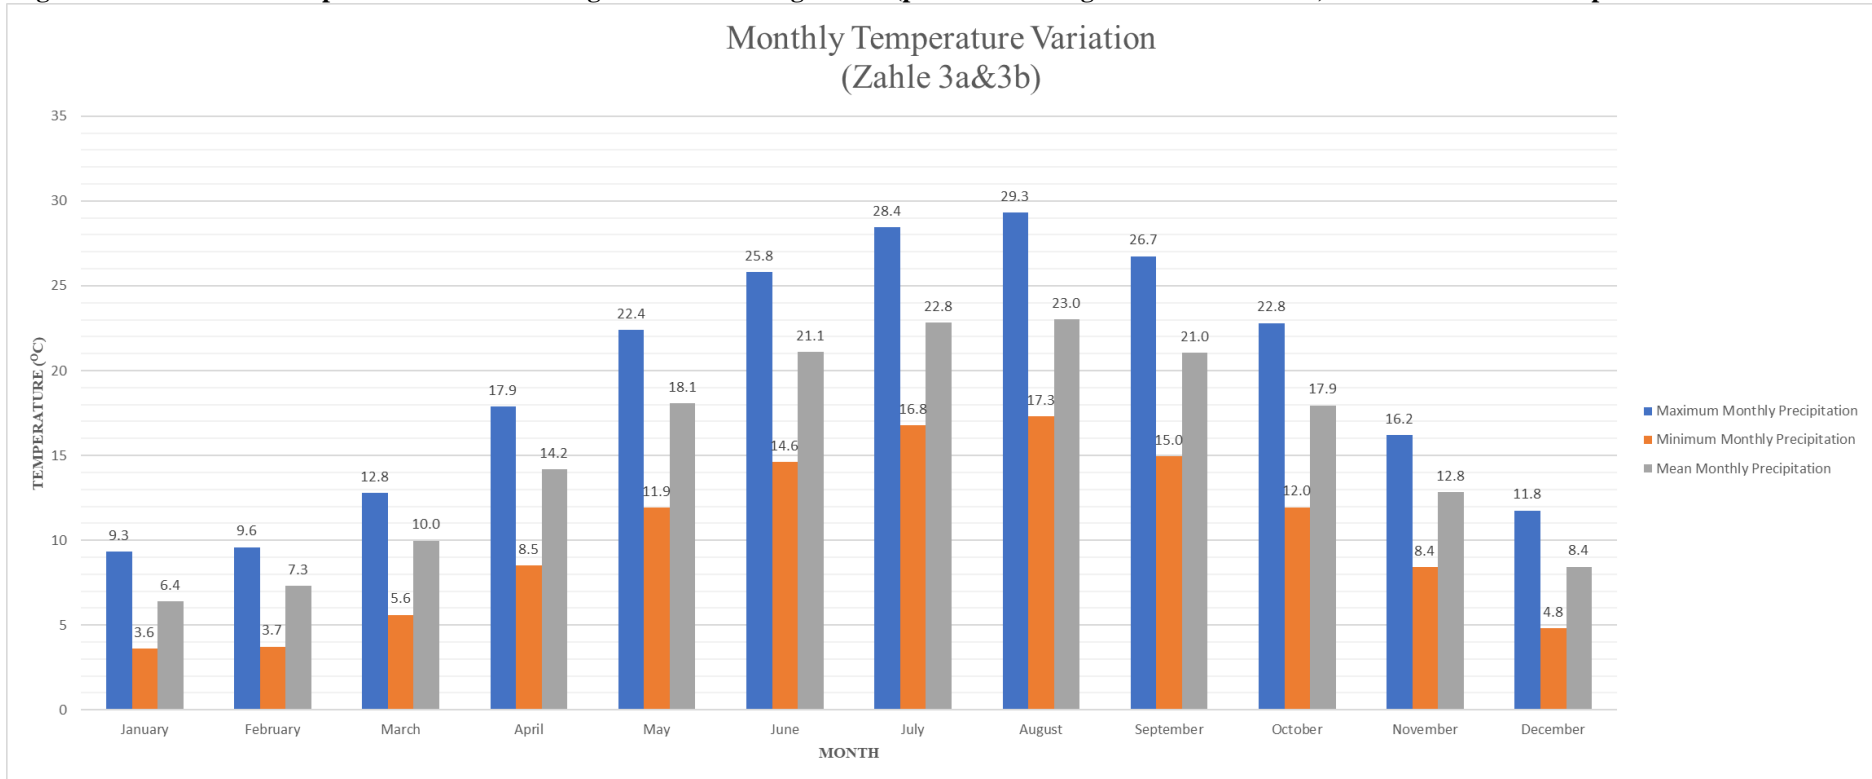
Figure K Land surface temperature variation along Zahle 3a&3b alignments (period extending between 2000-2018) MODIS satellite 1km spatial resolution

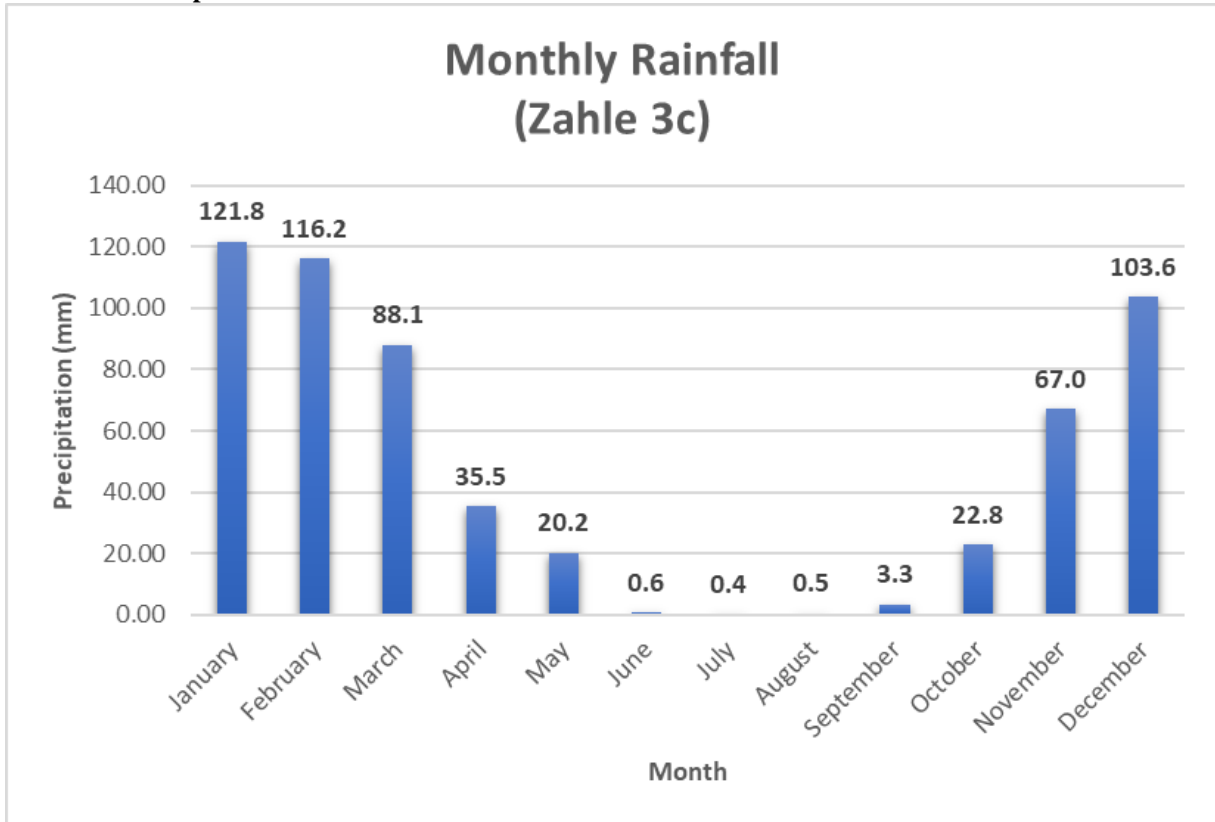
Figure L Precipitations values along Zahle 3c alignment (period extending between 1996-2018) CHIRPS satellite 4.5 km spatial resolution

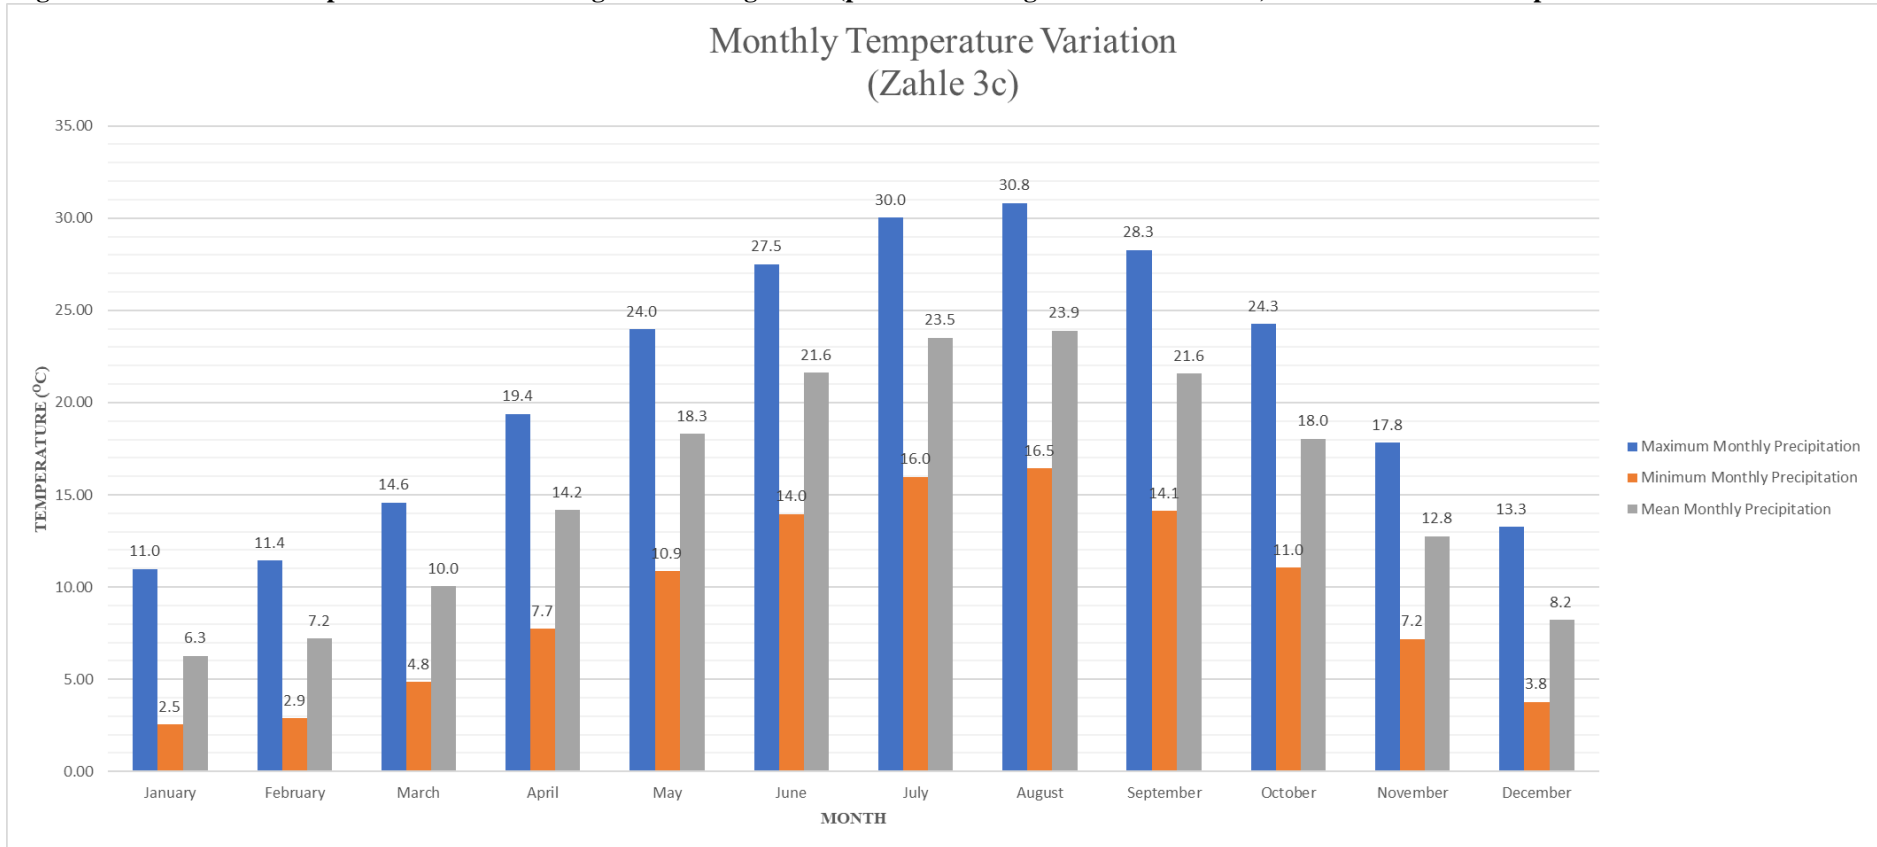
Figure M Land surface temperature variation along Zahle 3c alignment (period extending between 2000-2018) MODIS satellite 1km spatial resolution

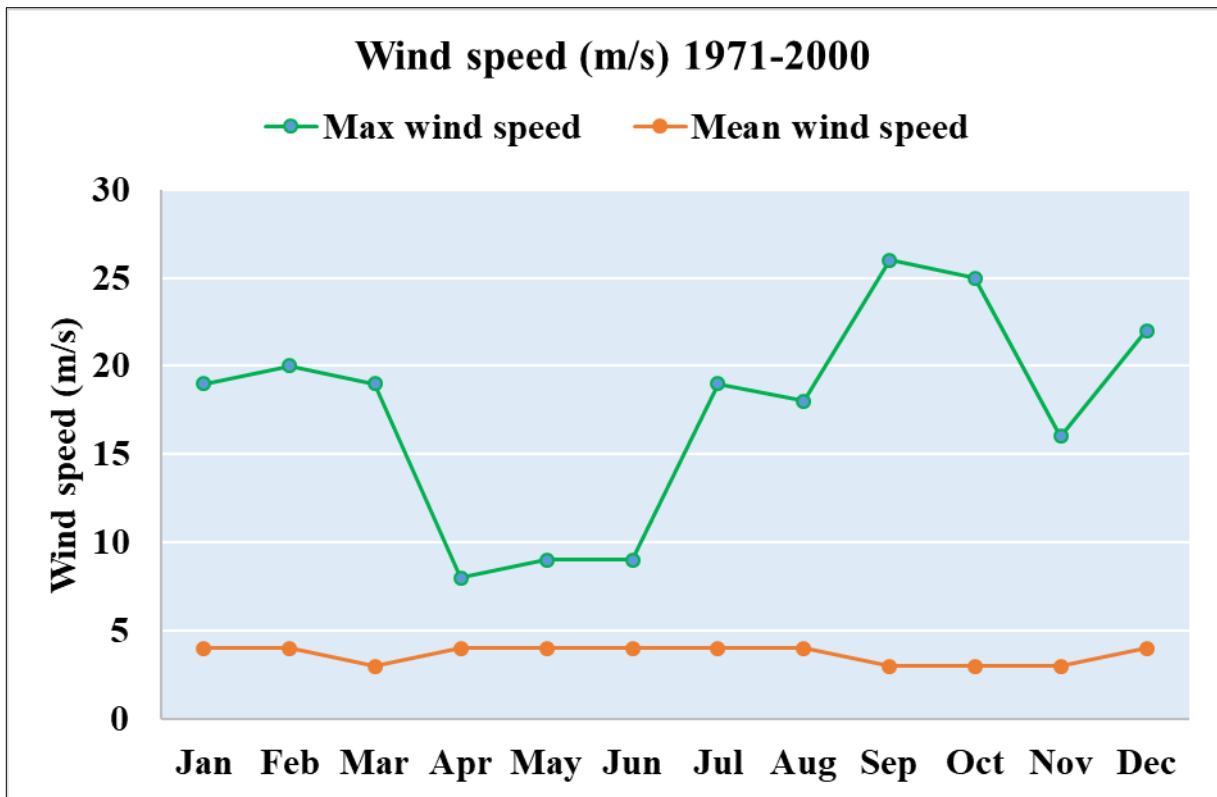
Figure N Average monthly wind speed and maximum monthly wind speed at Zahle Station from 1971 until 2000.

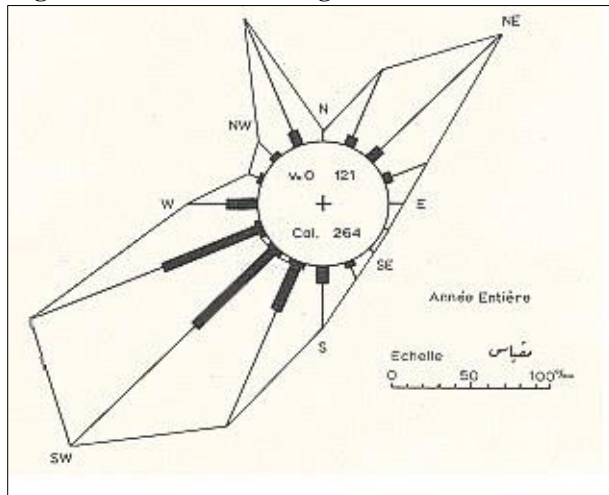
Figure O Windrose showing wind direction recorded in Riyak station

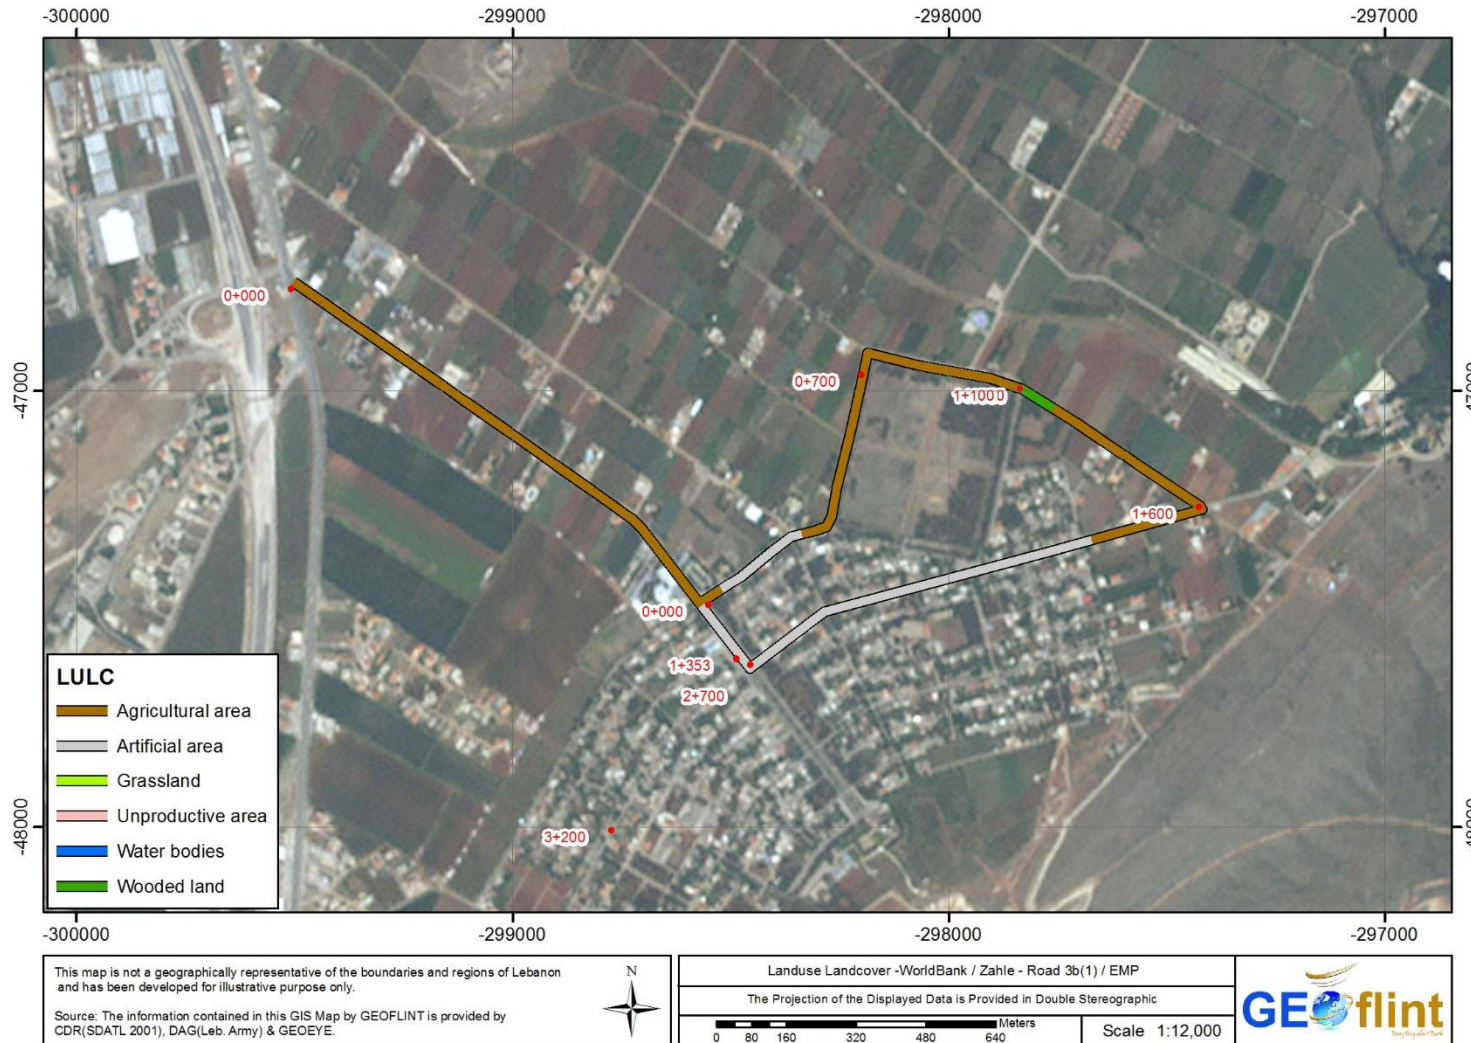
Figure Q LULC map with work stations along Zahle R3b alignment (section 1)

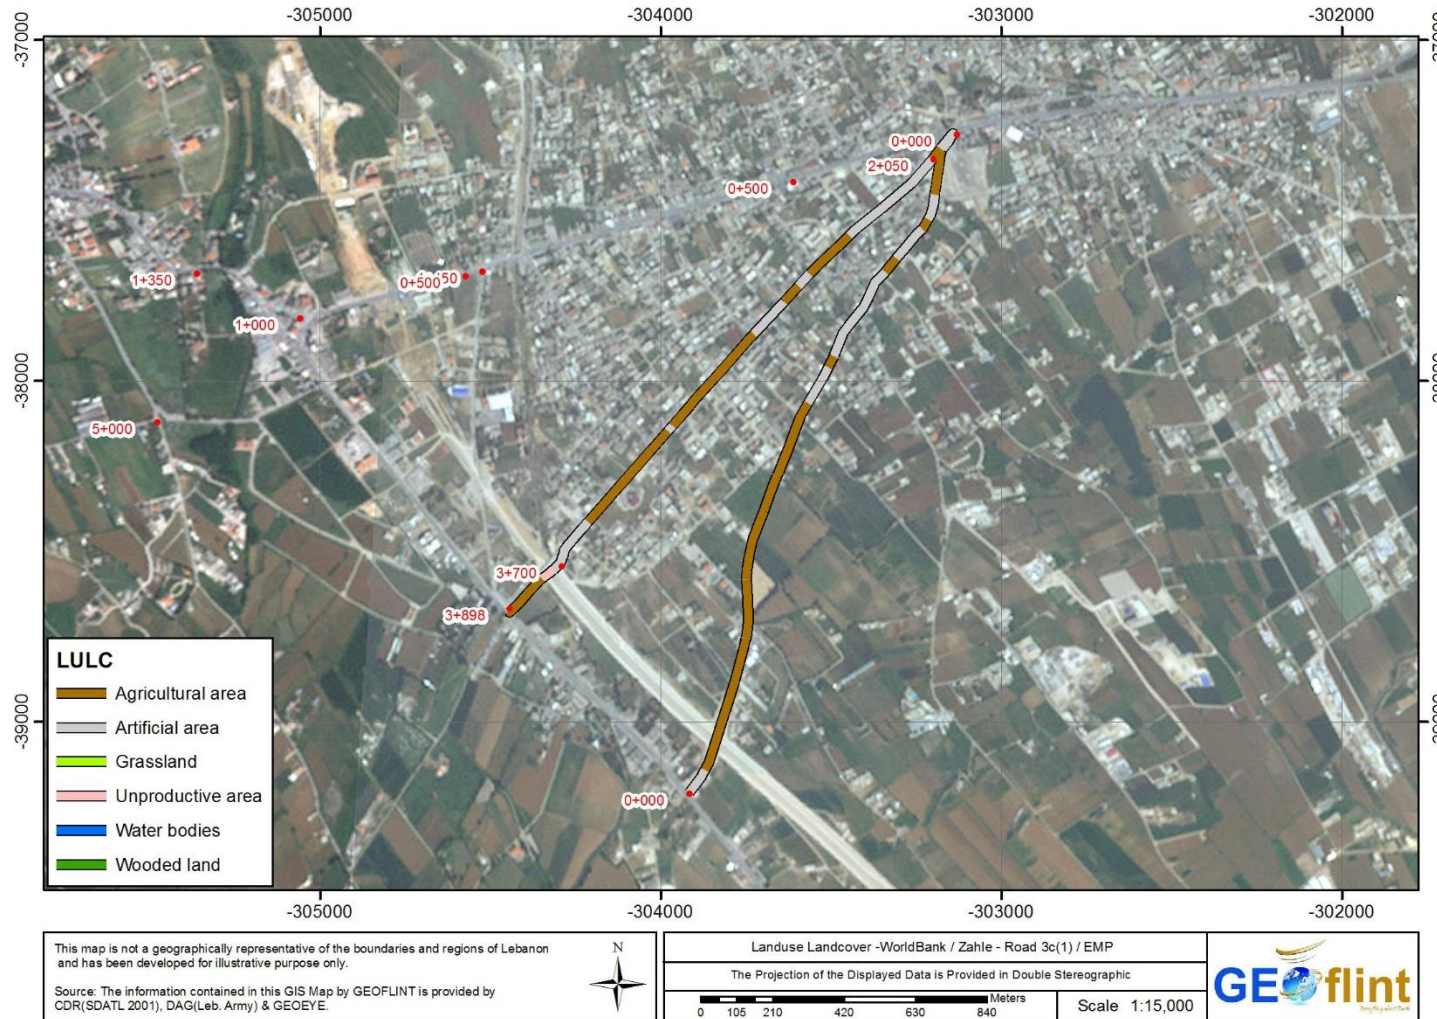
Figure S LULC map with work stations along Zahle R3c alignment (section 1)

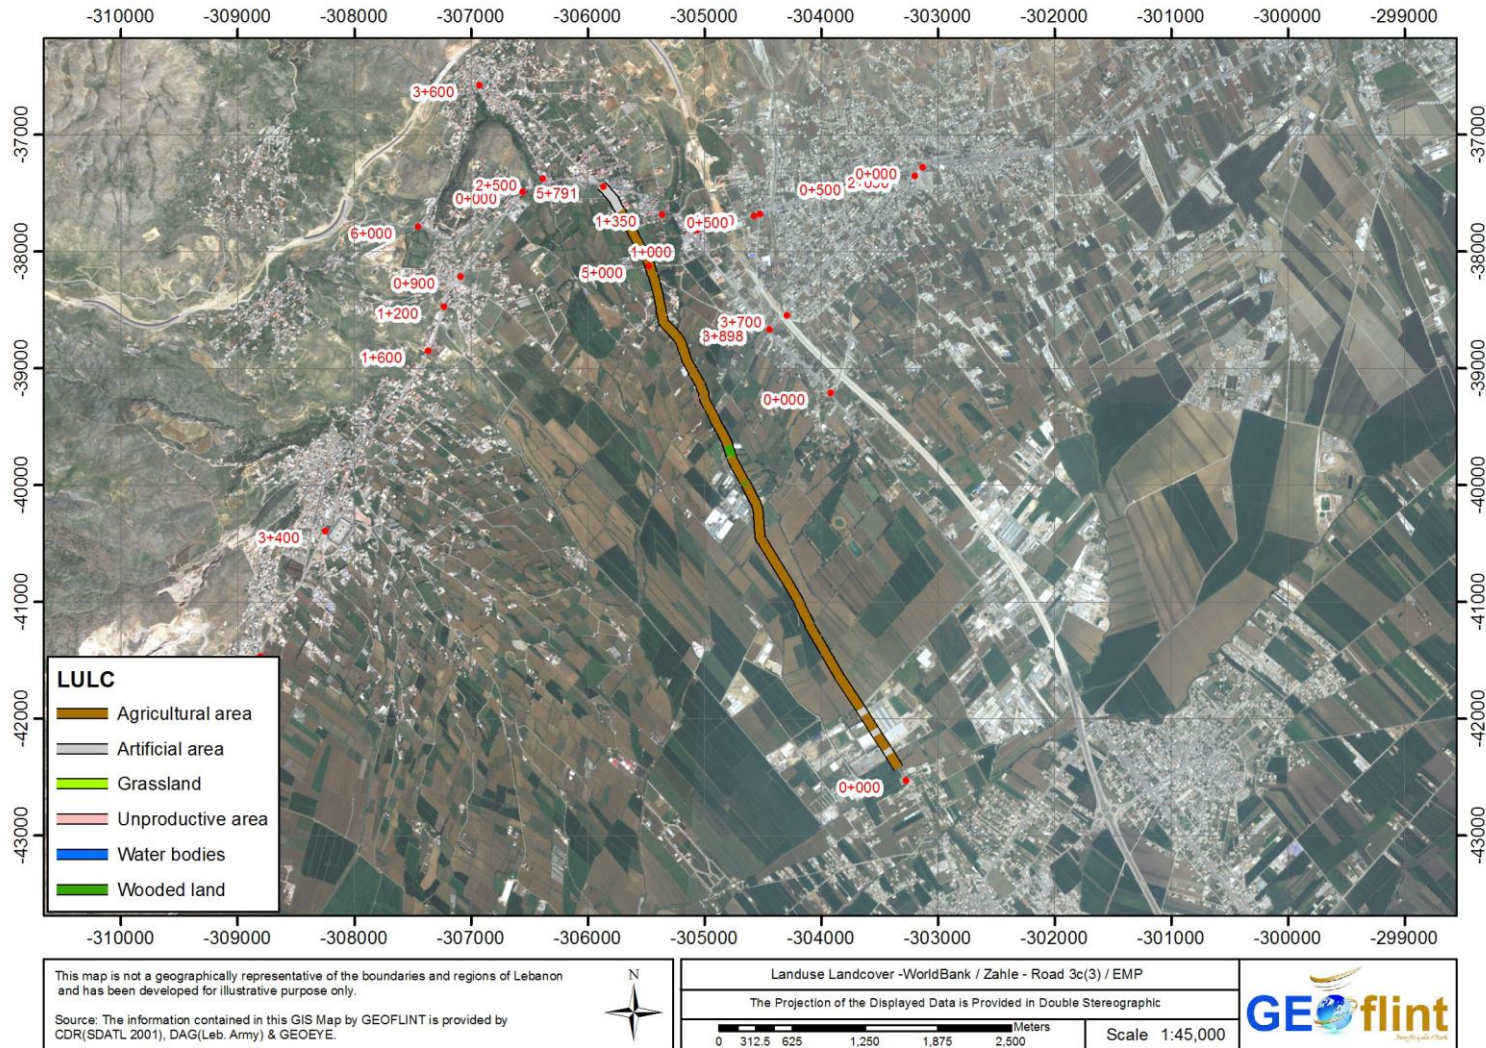
Figure U LULC map with work stations along Zahle R3c alignment (section 3)

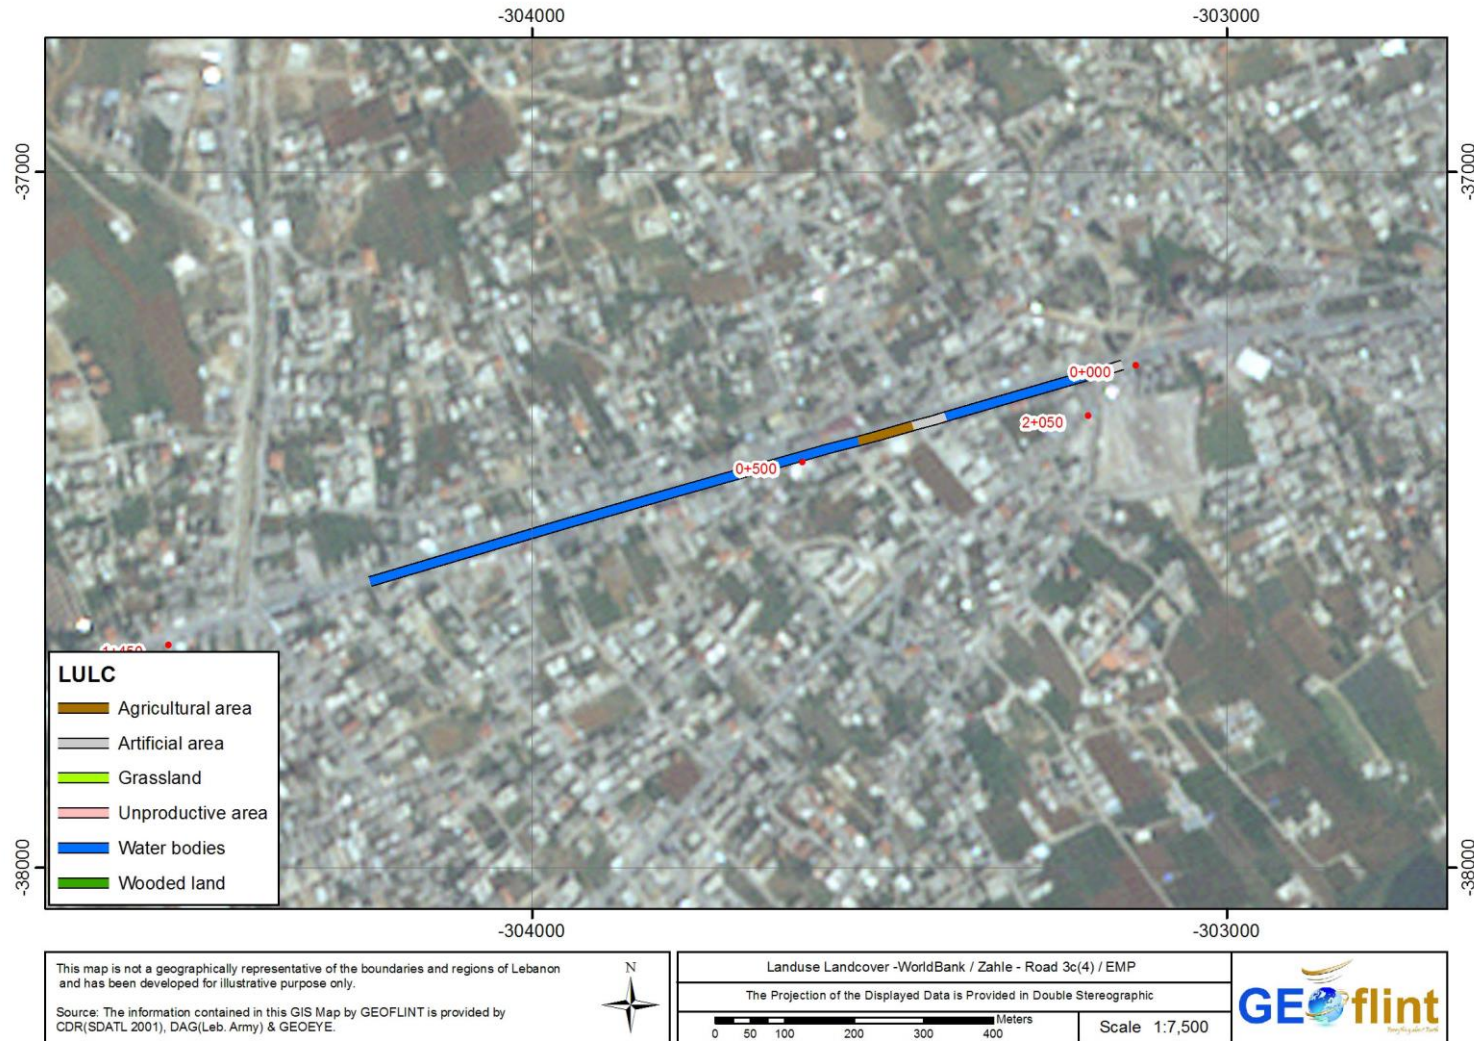
Figure V LULC map with work stations along Zahle R3c alignment (section 4)

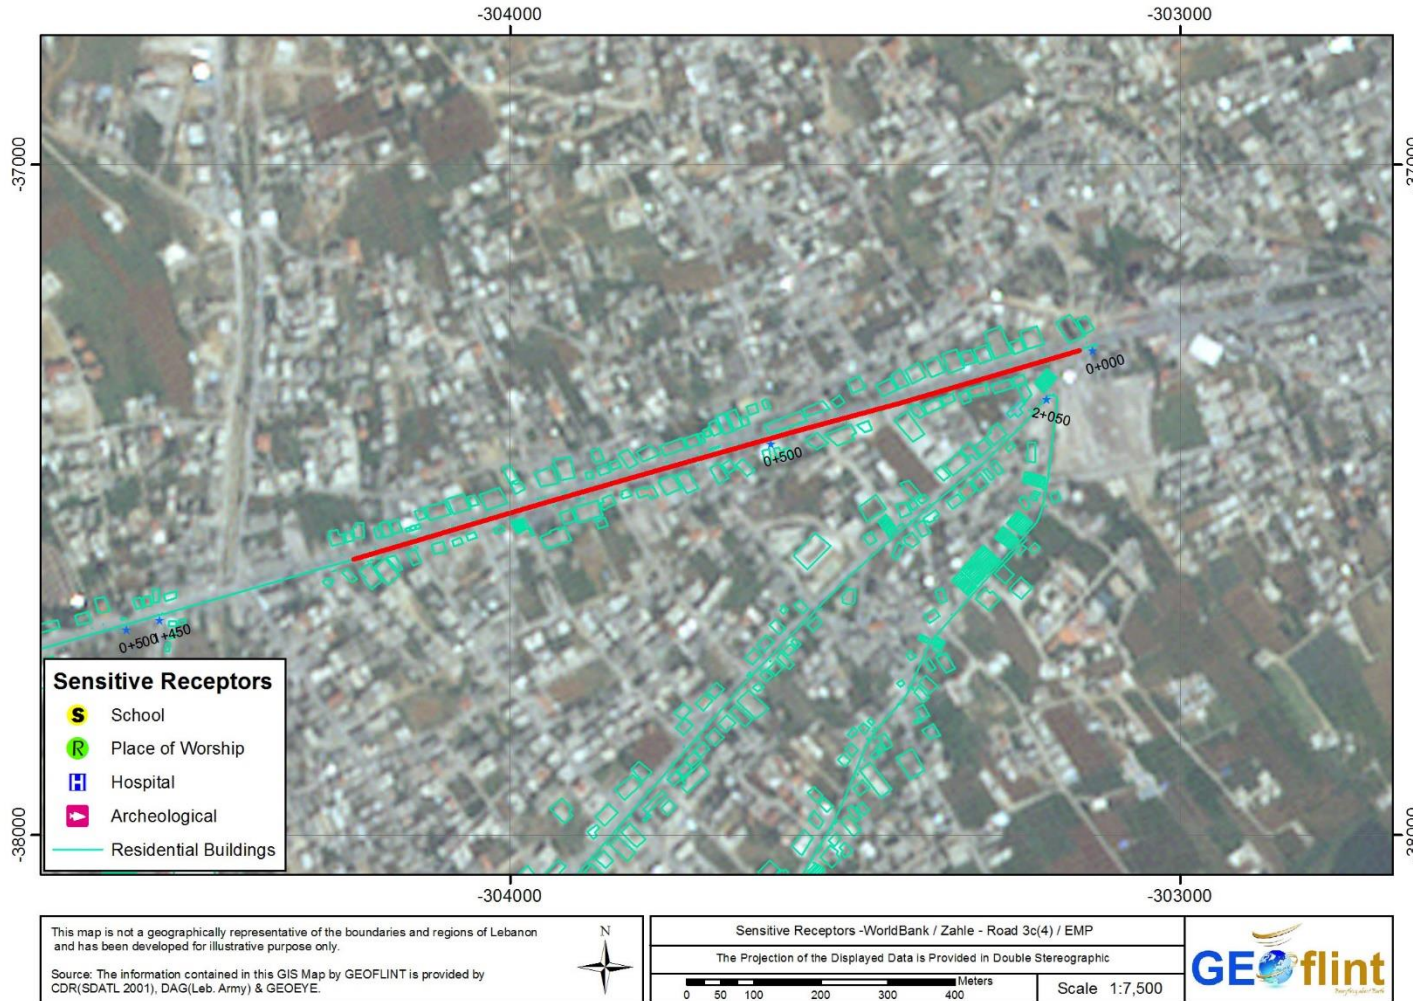
Figure CC Closest sensitive receptors along Zahle R3c (section 4)

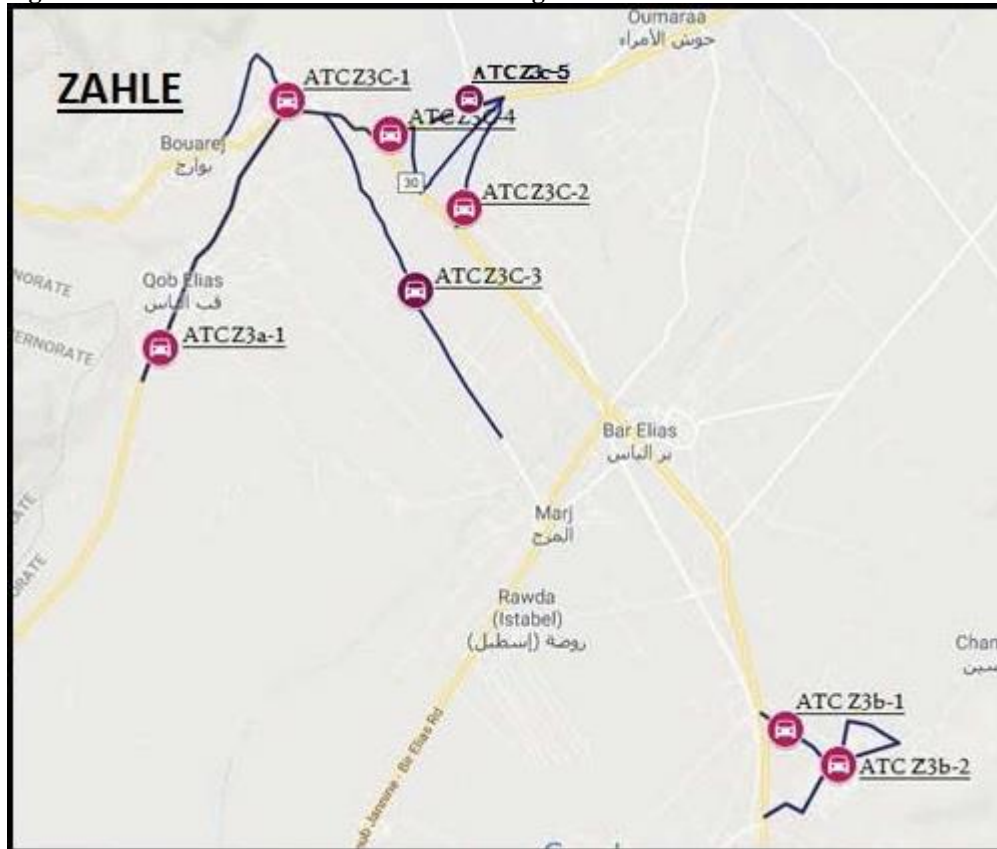
Figure DD Distribution of ATC Stations throughout Zahle Caza
