# ROADS & EMPLOYMENT PROJECT

DETAILED ENGINEERING DESIGN FOR THE  
REHABILITATION OF SELECTED ROAD LINKS IN LEBANON

## LOT 3A

Final Report

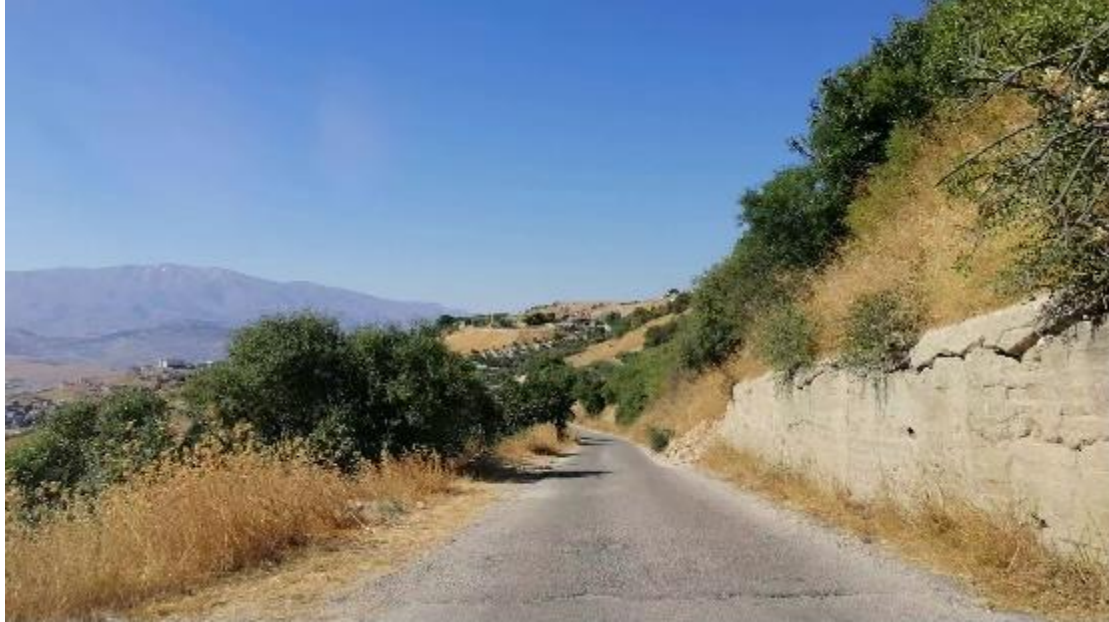
**Figure 3-6: Road L3-RA-RD02 (Station 3+150 of Rafid – Bire to Al Masnaa Road)**

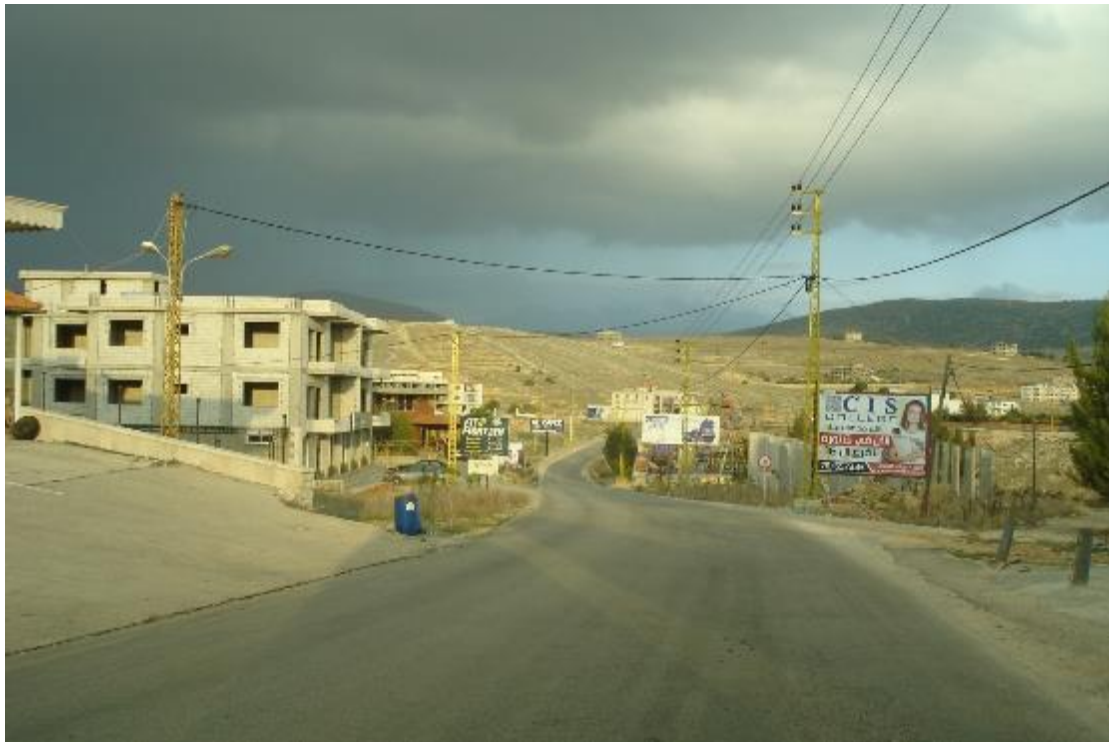
**Figure 3-7: Road L3-RA-RD01 (Station 2+500 of Dahr el Ahmar – Kawkaba – to Rachaya Hasbaya Intersection)**

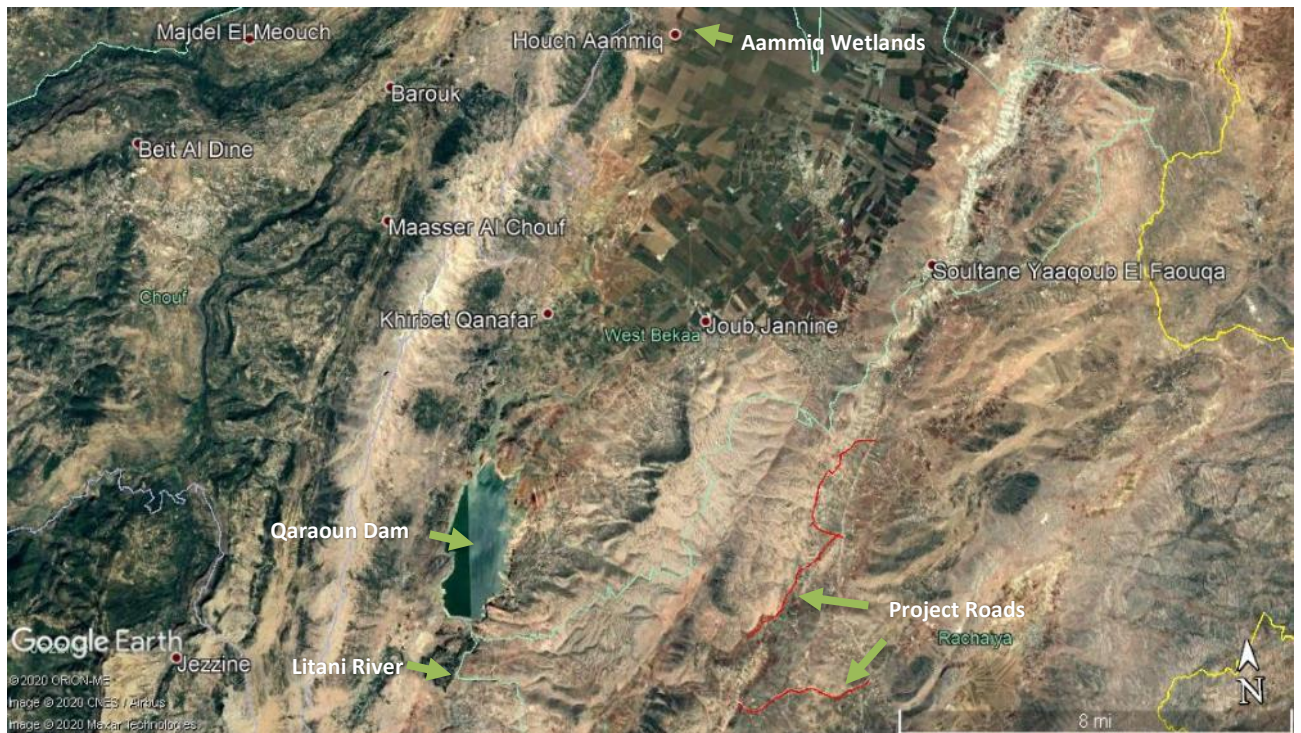
**Figure 4-2: Water Resources near Project Roads**

During the site visit in February 2020, a fresh water source was identified at Station 1 Km 900 m in Kawkaba village (L3-RA-RD04). Moreover, several water courses are located within the study area mainly for L3-RA-RD01 and L3-RA-RD02. L3-RA-RD04 does not include a watershed. Figure 4-3 represents the hydrological maps of the proposed area including the roads of the project L3-RA-RD01 and L3-RA-RD02 with respect to the rivers and their watersheds in the Caza of Rachaya, the villages of Rafid, Bire (L3-RA-RD02) and Kawkaba, Mhaydthe (L3-RA-RD01) are crossed at some section with these water courses.

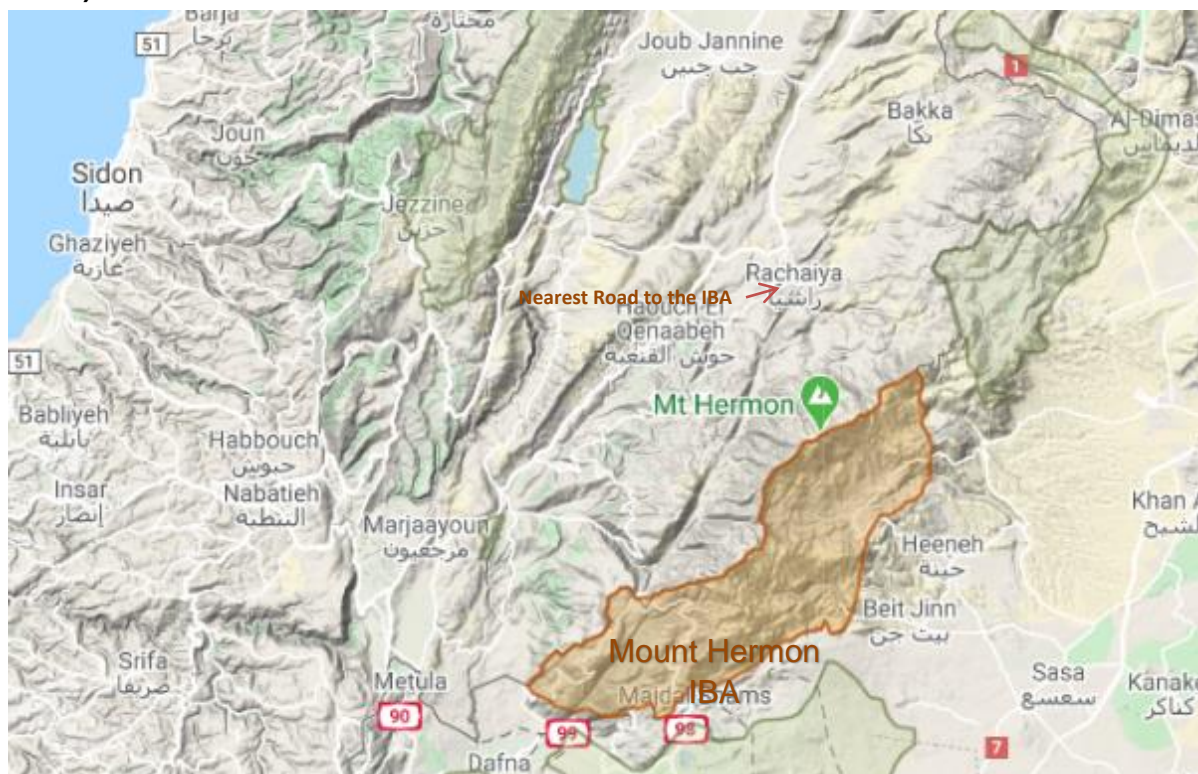
**Figure 4-10: Location of Mount Hermon IBA in reference to the nearest road (L3-RA-RD01) at Dahr El Ahmar**

The District of Rachaya comprises the Mount Hermon area that was declared in 1994 as an Important Bird Area (IBA) by BirdLife International. However, the nearest road L3-RA-RD01 in Dahr El Ahmar is about 9 km away from this IBA (Figure 4-10). The closest protected area to the project site is Al Shouf Biosphere Reserve that is around 15.5 km away from the village Bire (L3-RA-RD02). Moreover, the municipality of Rachaya Al Wadi that is considered the capital of the Caza is planning to establish the Rachaya Nature Reserve in collaboration with the MOE and Al Shouf Biosphere Reserve.
