**REHABILITATION OF SELECTED ROAD LINKS
IN LEBANON**

LOT 1 (CAZA ALEY)

**Environmental and Social Management Plan
(ESMP)**

**October 2020
(REV 0)**

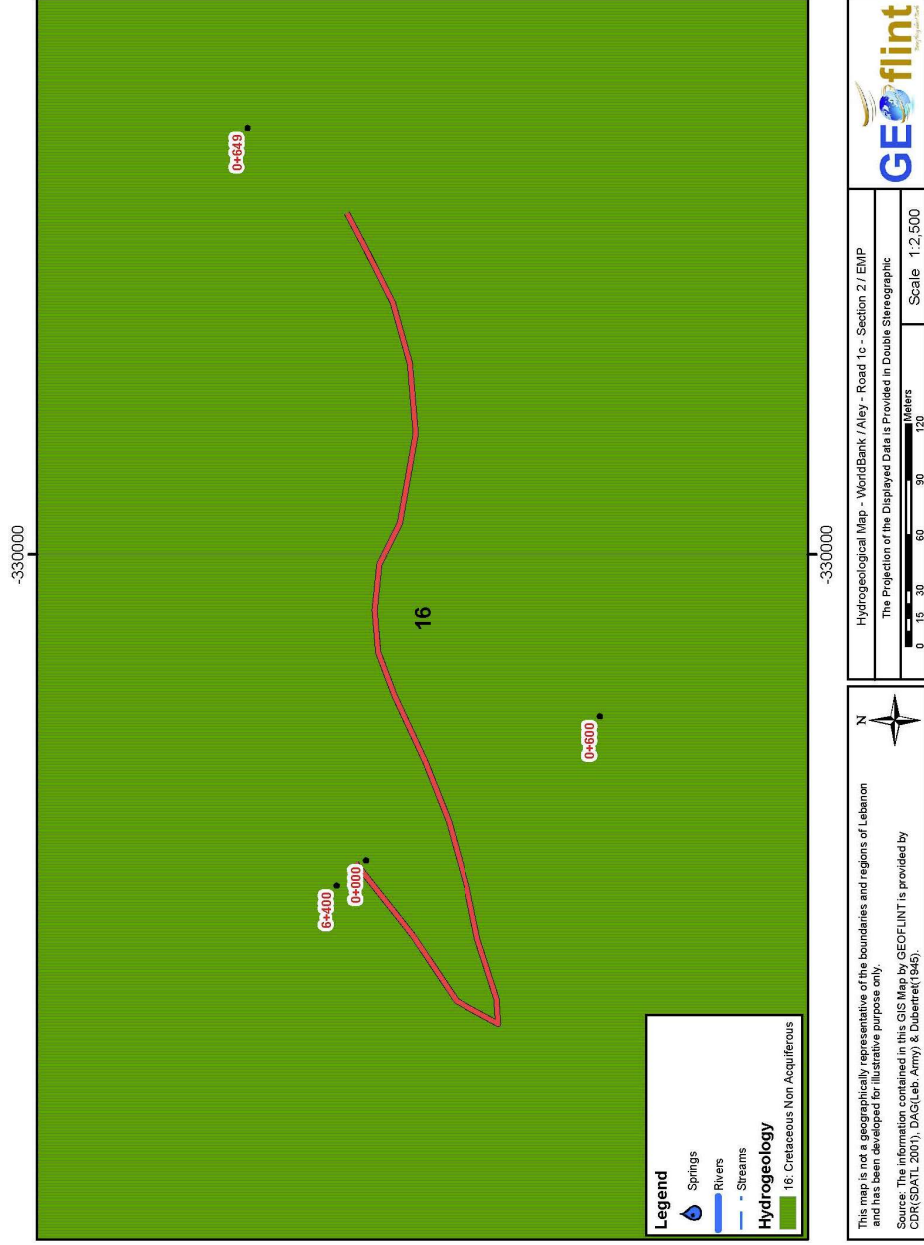
Figure N Hydrogeological map of Aley R1c section 2 and its surrounding (map showing water potential of the subsurface). Refer to Table 4-3 for description of hydrogeology classes. Work stations are shown along the road alignment.

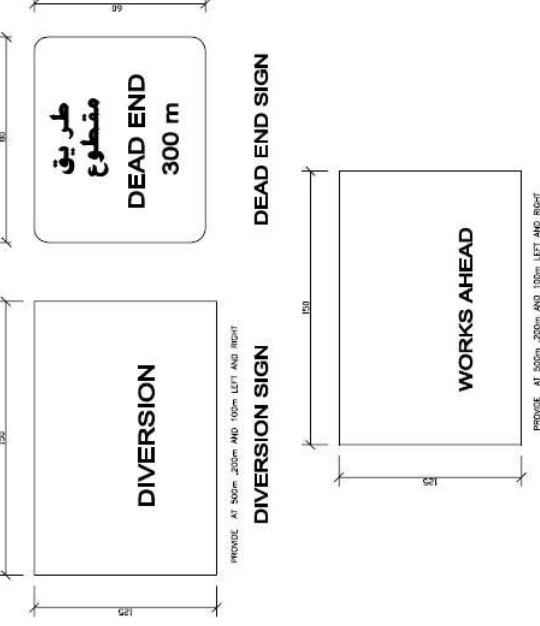
WARNING SIGNS TYPE AK	BY FLAGMEN
<p style="text-align: center;">SIDE 0.70 m</p> <p>AK2, AK3, AK4, AK5, AK14, AK17, AK22, AK14+KM9+KM2 EXAMPLE, AK3+KM1, AK5+KM9</p>	<p style="text-align: center;">STANDARD SIGNS PADDLE</p>

<p>TEMPORARY TRAFFIC LIGHTS AT START AND AT END OF EVERY DIVERSION OR TEMPORARY WORK BATTERY OPERATED OR BY GENERATOR</p>

<p>FLASHING AMBER LIGHT BATTERY OPERATED AT 10m CENTER REFLECTORIZED DIVERSION</p>	<p>WARNING SIGNS TYPE KC</p>

<p>100 150 90 100 150</p> <p>DIVERSION PROVIDE AT 500m, 200m AND 100m LEFT AND RIGHT</p> <p>DEAD END SIGN DEAD END SIGN</p> <p>WORKS AHEAD SIGN PROVIDE AT 500m, 200m AND 100m LEFT AND RIGHT</p>
---	---	--	---
