**REHABILITATION OF SELECTED ROAD LINKS  
IN LEBANON**

**LOT 2 (CAZA CHOUF)**

**Environmental and Social Management Plan  
(ESMP)**

**October 2020  
(REV 0)**

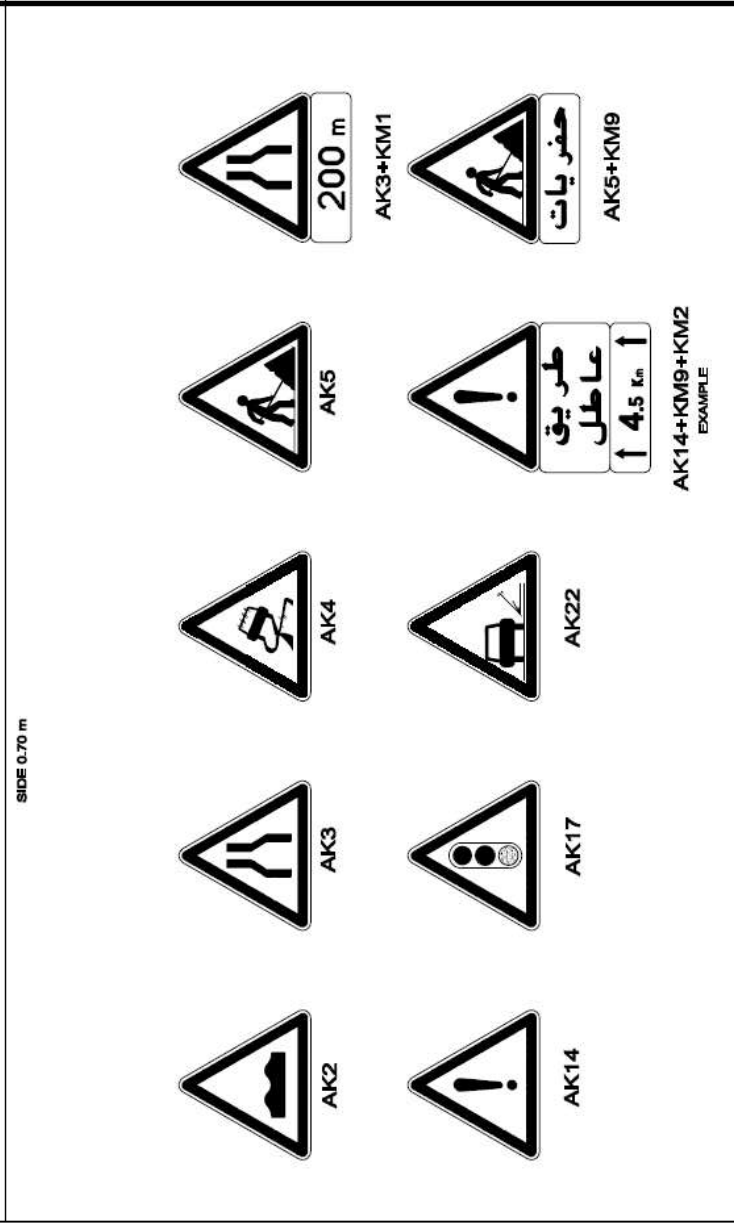
WARNING SIGNS TYPE AK	BY FLAGMEN
<p style="text-align: center;">SIDE 0.70 m</p>
