Republic of Lebanon - Council for Development and Reconstruction

Road and Employment Project (REP)

Environmental and Social Management Plan (ESMP)

LOT 2: Caza of Chouf

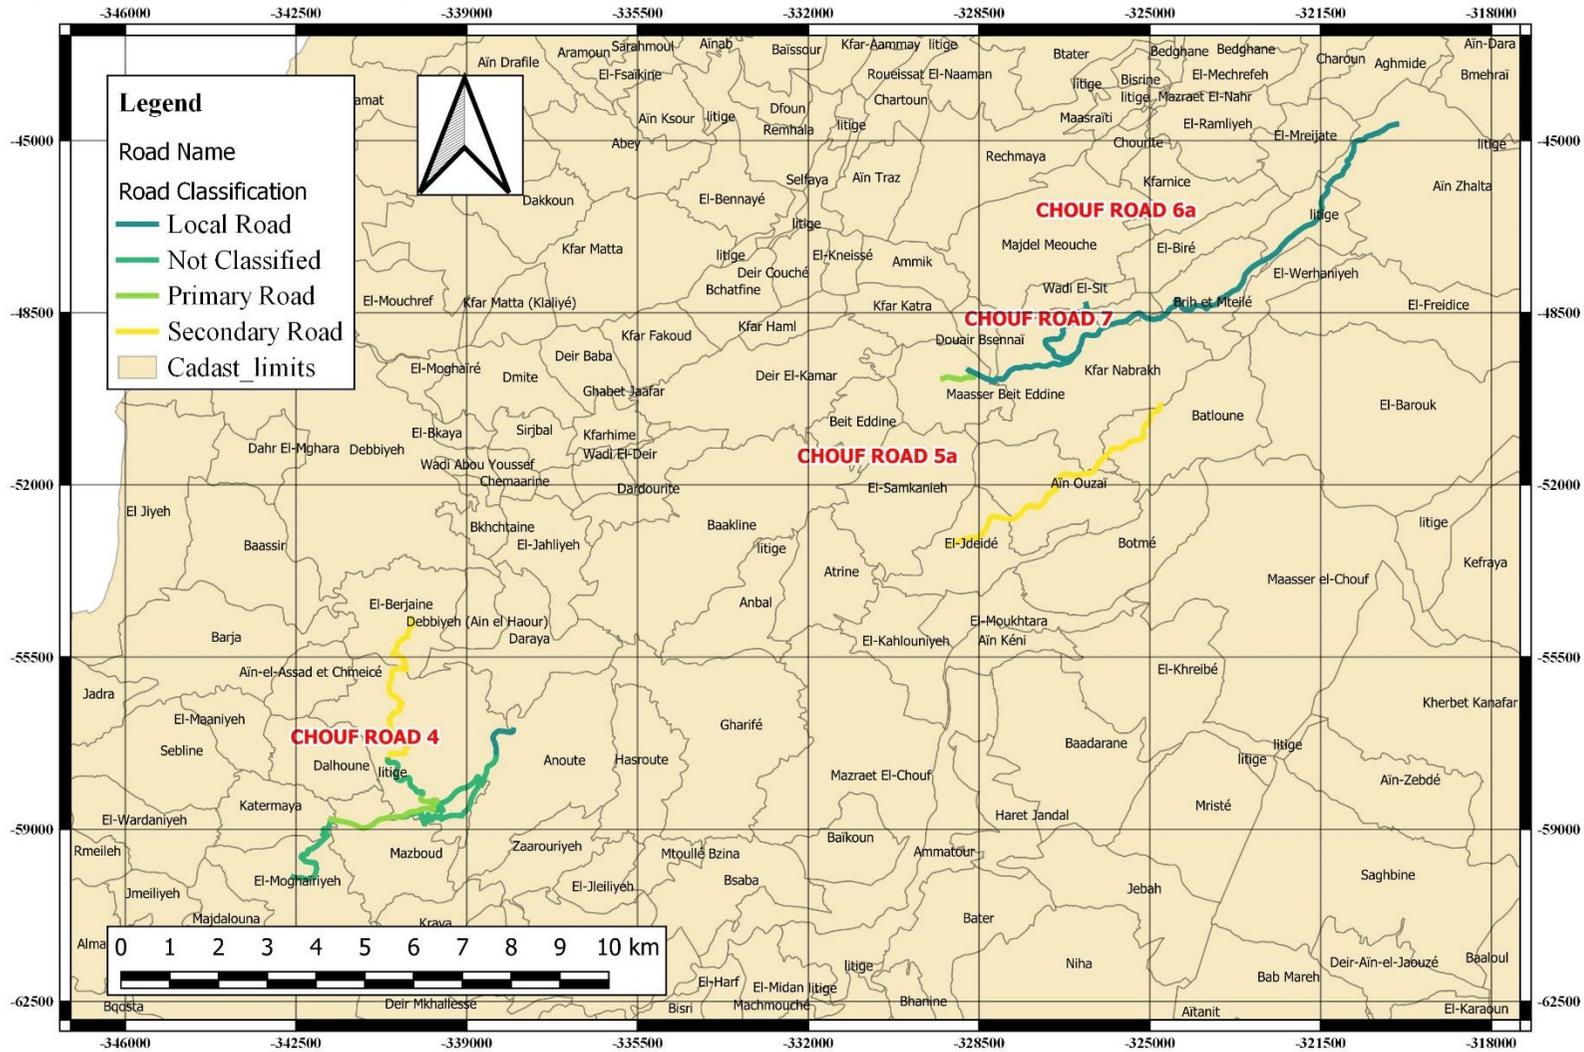
Figure 3-1 Classification of road segments of Chouf roads

Caza	Road Code	Section	Cadastral Borders	Length (km)	Road Classification
Chouf	4	1	El-Moghairiyeh – Mazboud – Chehime	16.80	Primary, Secondary, & Local
		2	Cehime		
		3	Cehime – El-Berjaine		
	5a	One continuous alignment	Batloune – Kfar Nabrahk – Ain Ouzain – El-Jdeide	5.90	Secondary
	6a	One continuous alignment	Ain Zhalta – Brih and Mteile – El-Fouara – Kfar Nabrahk – Maasser Beit Eddine	12.80	Local
7	One continuous alignment	Kfar Nabrahk – Wadi El-Sit	2.15	Local

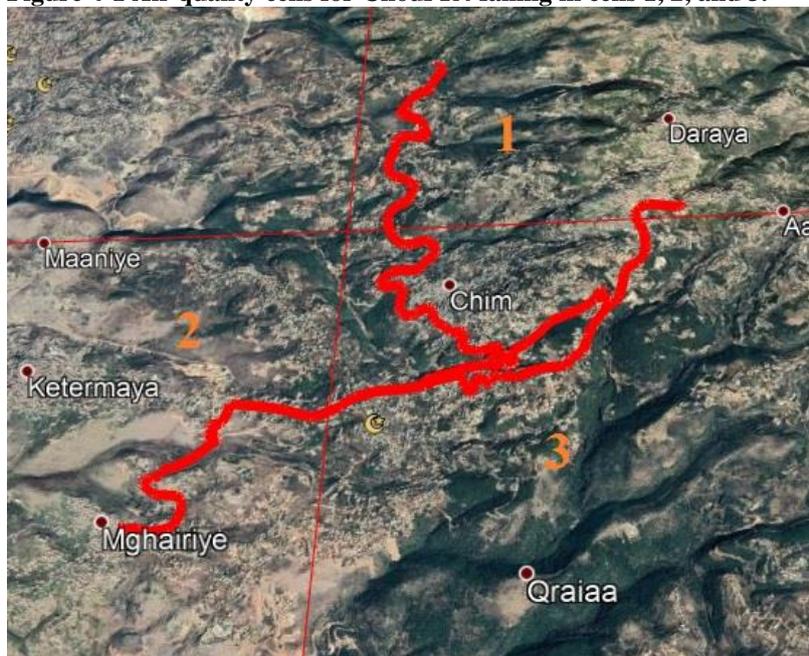
Figure 4-1 Air quality cells for Chouf R4 falling in cells 1, 2, and 3.

1	26.317	77.777	23.804	20.577	19.369	461.685
2	27.988	76.212	26.069	20.836	18.934	494.340
3	20.246	82.568	22.115	18.666	15.192	396.578
Lebanese Ambient Air Quality standards, Decision 52/1	100	100	80	-	80	10,000
NAAQS, EPA	107.6	147.7	150	35	84.6	11,070
Exposure Duration	1 year	8 hours	24 hours	24 hours	1 year	8 hours

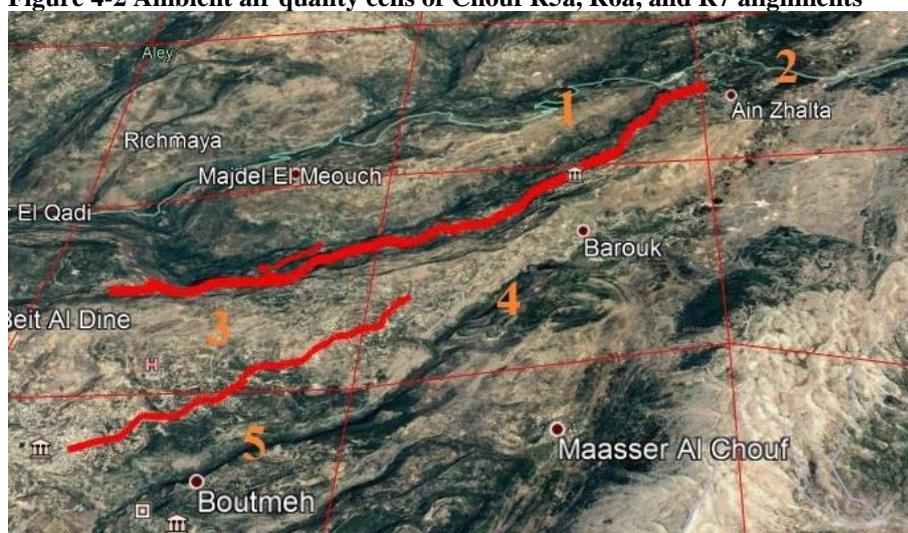
Figure 4-2 Ambient air quality cells of Chouf R5a, R6a, and R7 alignments

Table 4-5 Ambient air quality in $\mu\text{g}/\text{m}^3$ for of Chouf R5a (cells 3,4,5), R6a (cells 1,2,3,4), and R7 (cell 3)

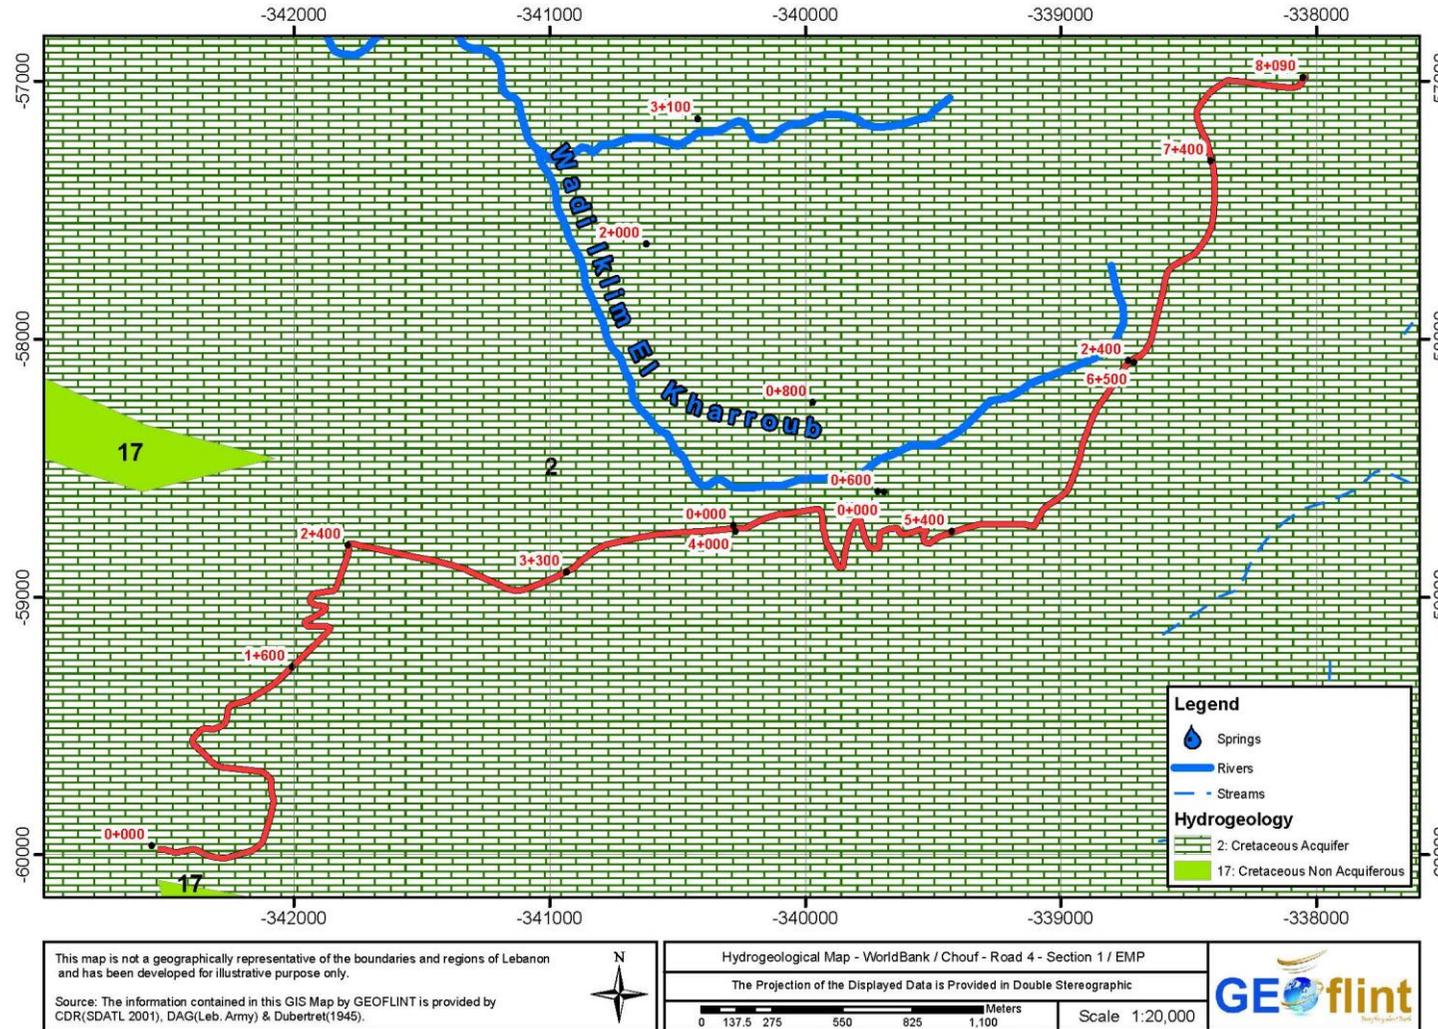
Figure M Hydrogeological map of Chouf R4 section 1 and its surrounding (map showing water potential of the subsurface). Refer to Table 4-3 for description of hydrogeology classes.

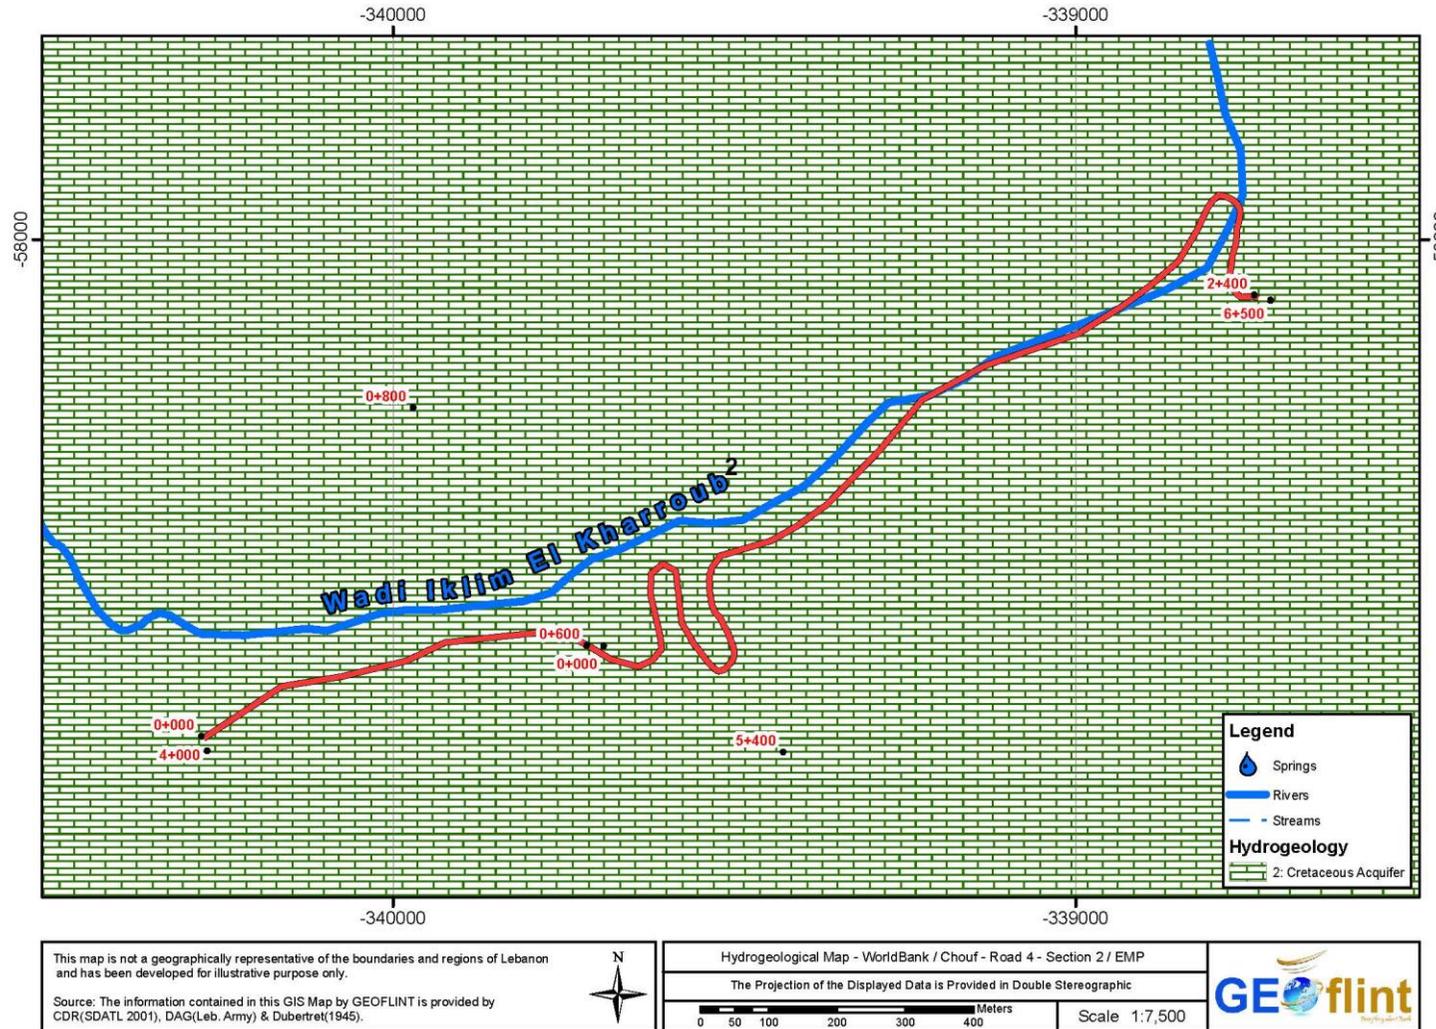
Figure N Hydrogeological map of Chouf R4 section 2 and its surrounding (map showing water potential of the subsurface). Refer to Table 4-3 for description of hydrogeology classes. Work stations are shown along the road alignment.

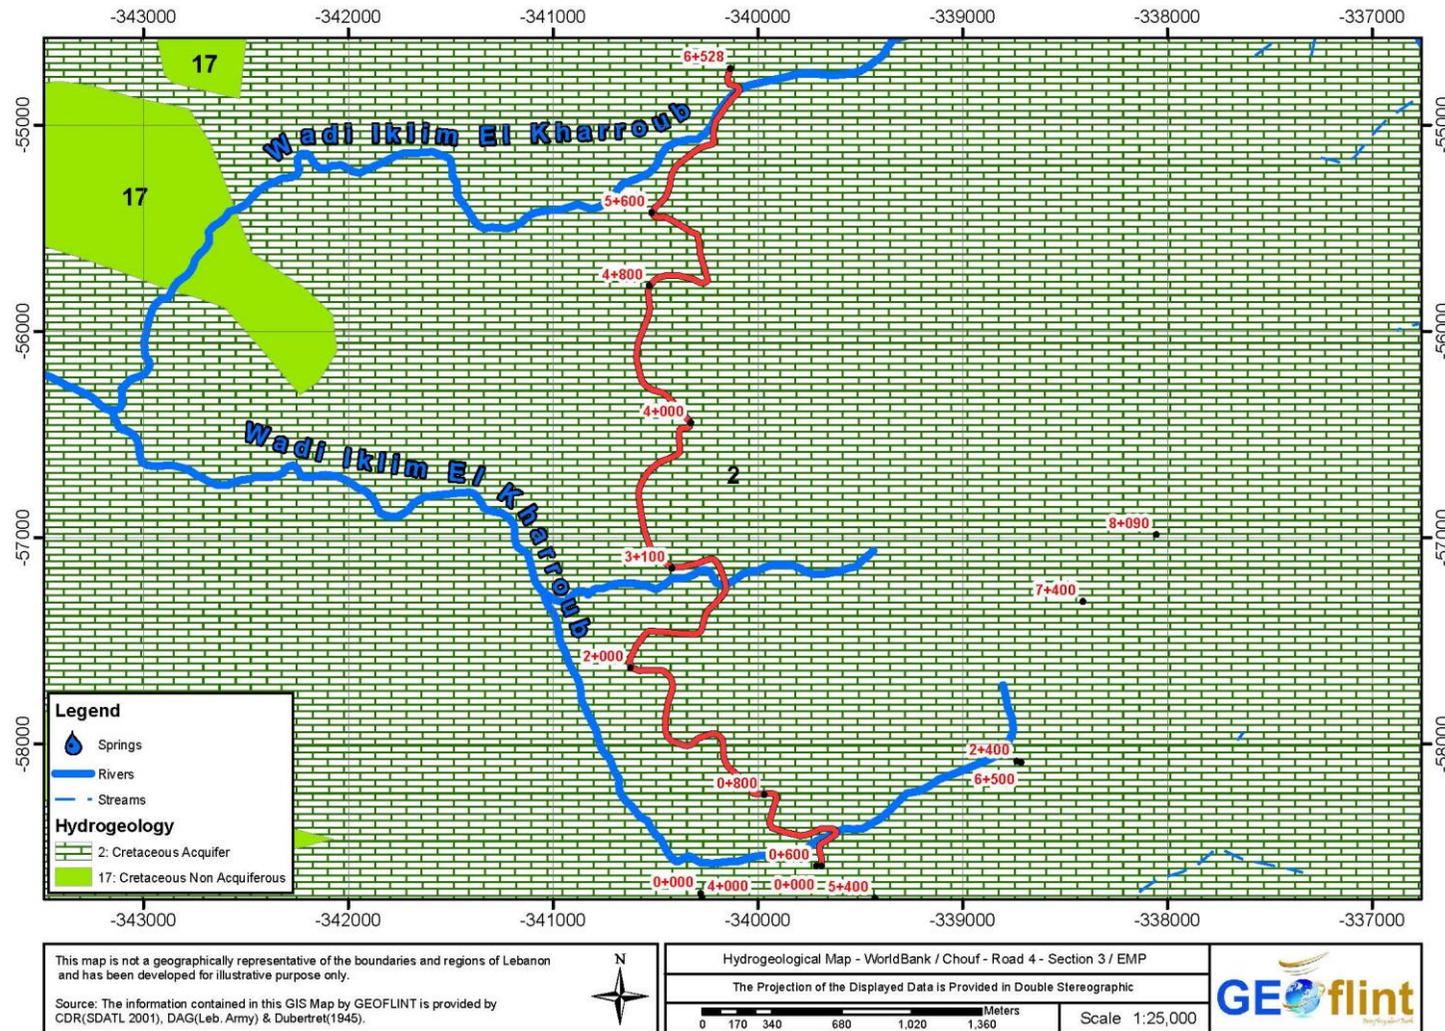
Figure O Hydrogeological map of Chouf R4 section 3 and its surrounding (map showing water potential of the subsurface). Refer to Table 4-3 for description of hydrogeology classes. Work stations are shown along the road alignment.

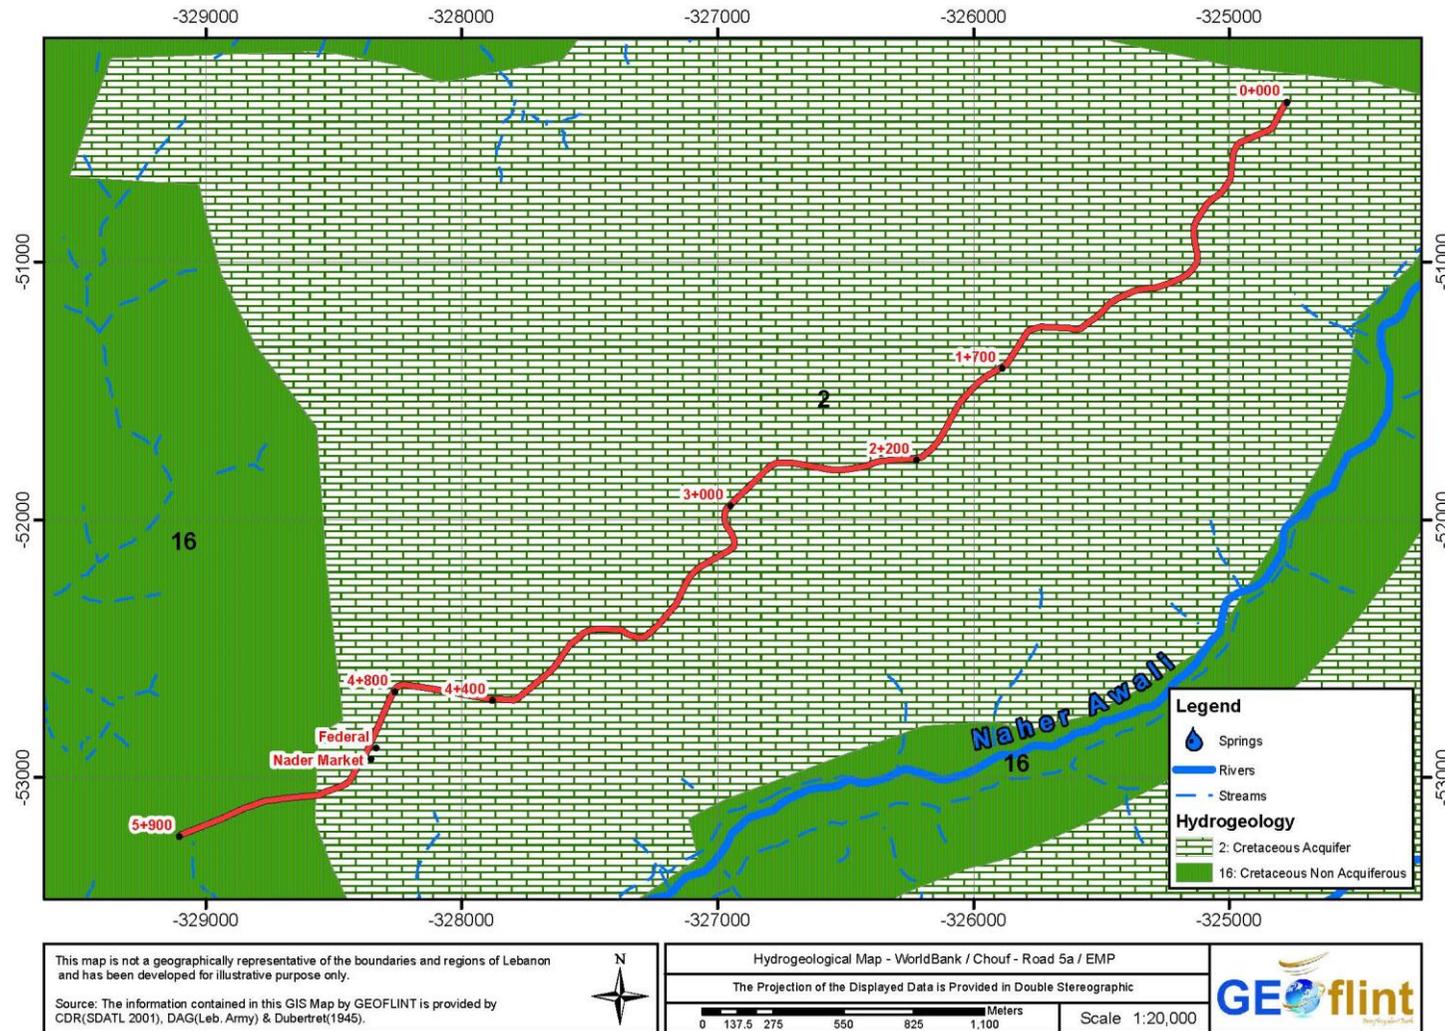
Figure P Hydrogeological map of Chouf R5a and its surrounding (map showing water potential of the subsurface). Refer to Table 4-3 for description of hydrogeology classes. Work stations are shown along the road alignment.

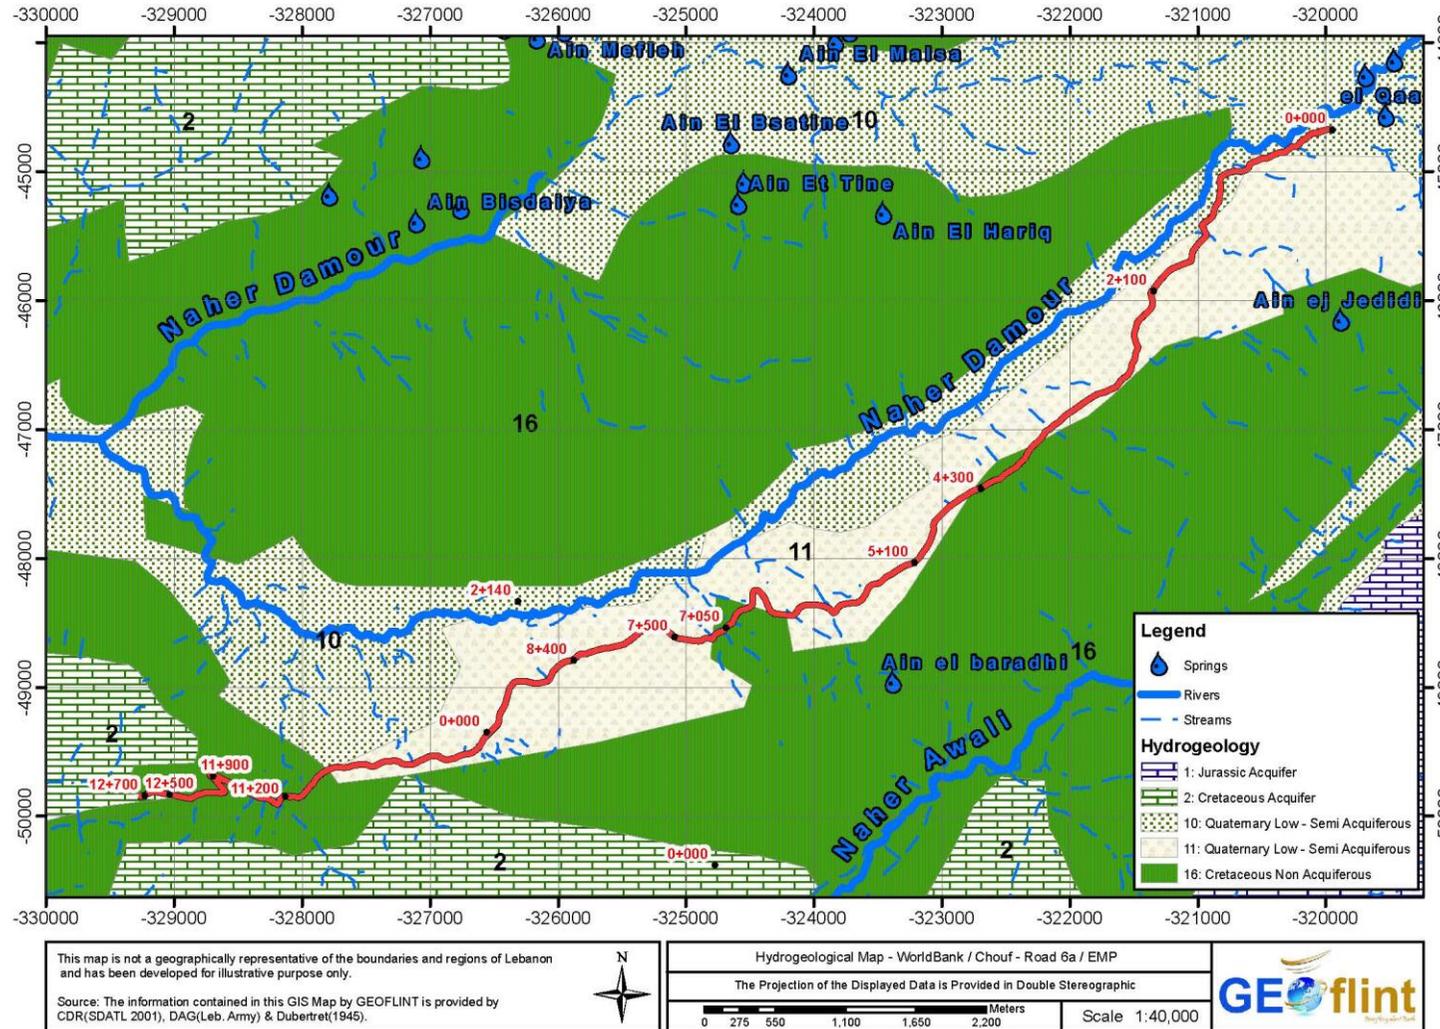
Figure Q Hydrogeological map of Chouf R6a and its surrounding (map showing water potential of the subsurface). Refer to Table 4-3 for description of hydrogeology classes. Work stations are shown along the road alignment.

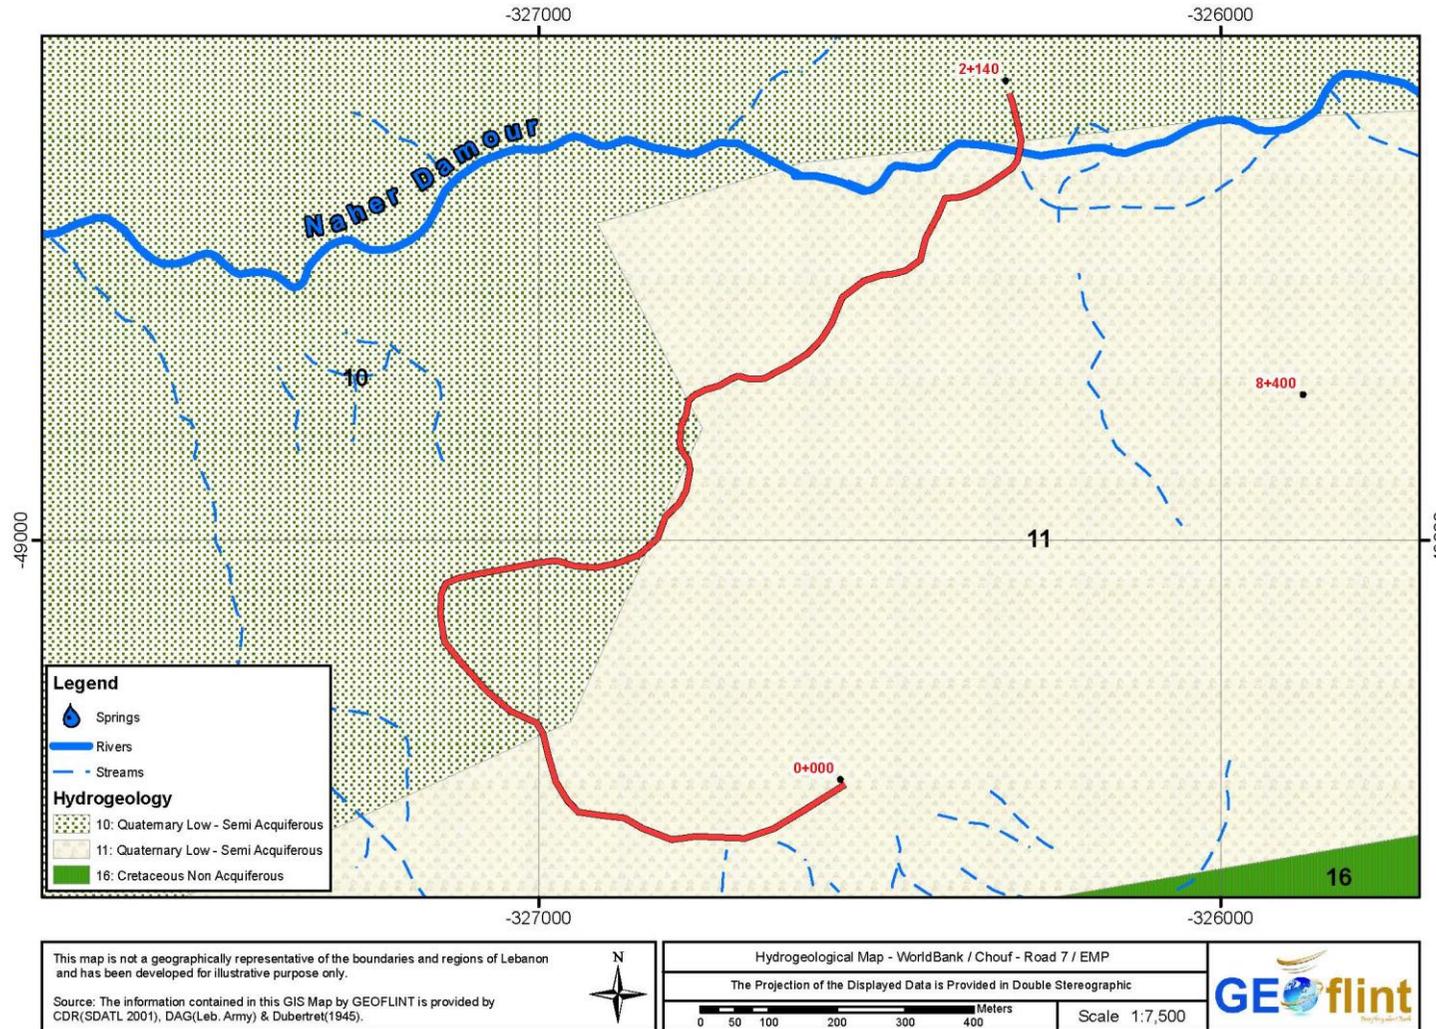
Figure R Hydrogeological map of Chouf R7 and its surrounding (map showing water potential of the subsurface). Refer to Table 4-3 for description of hydrogeology classes. Work stations are shown along the road alignment.

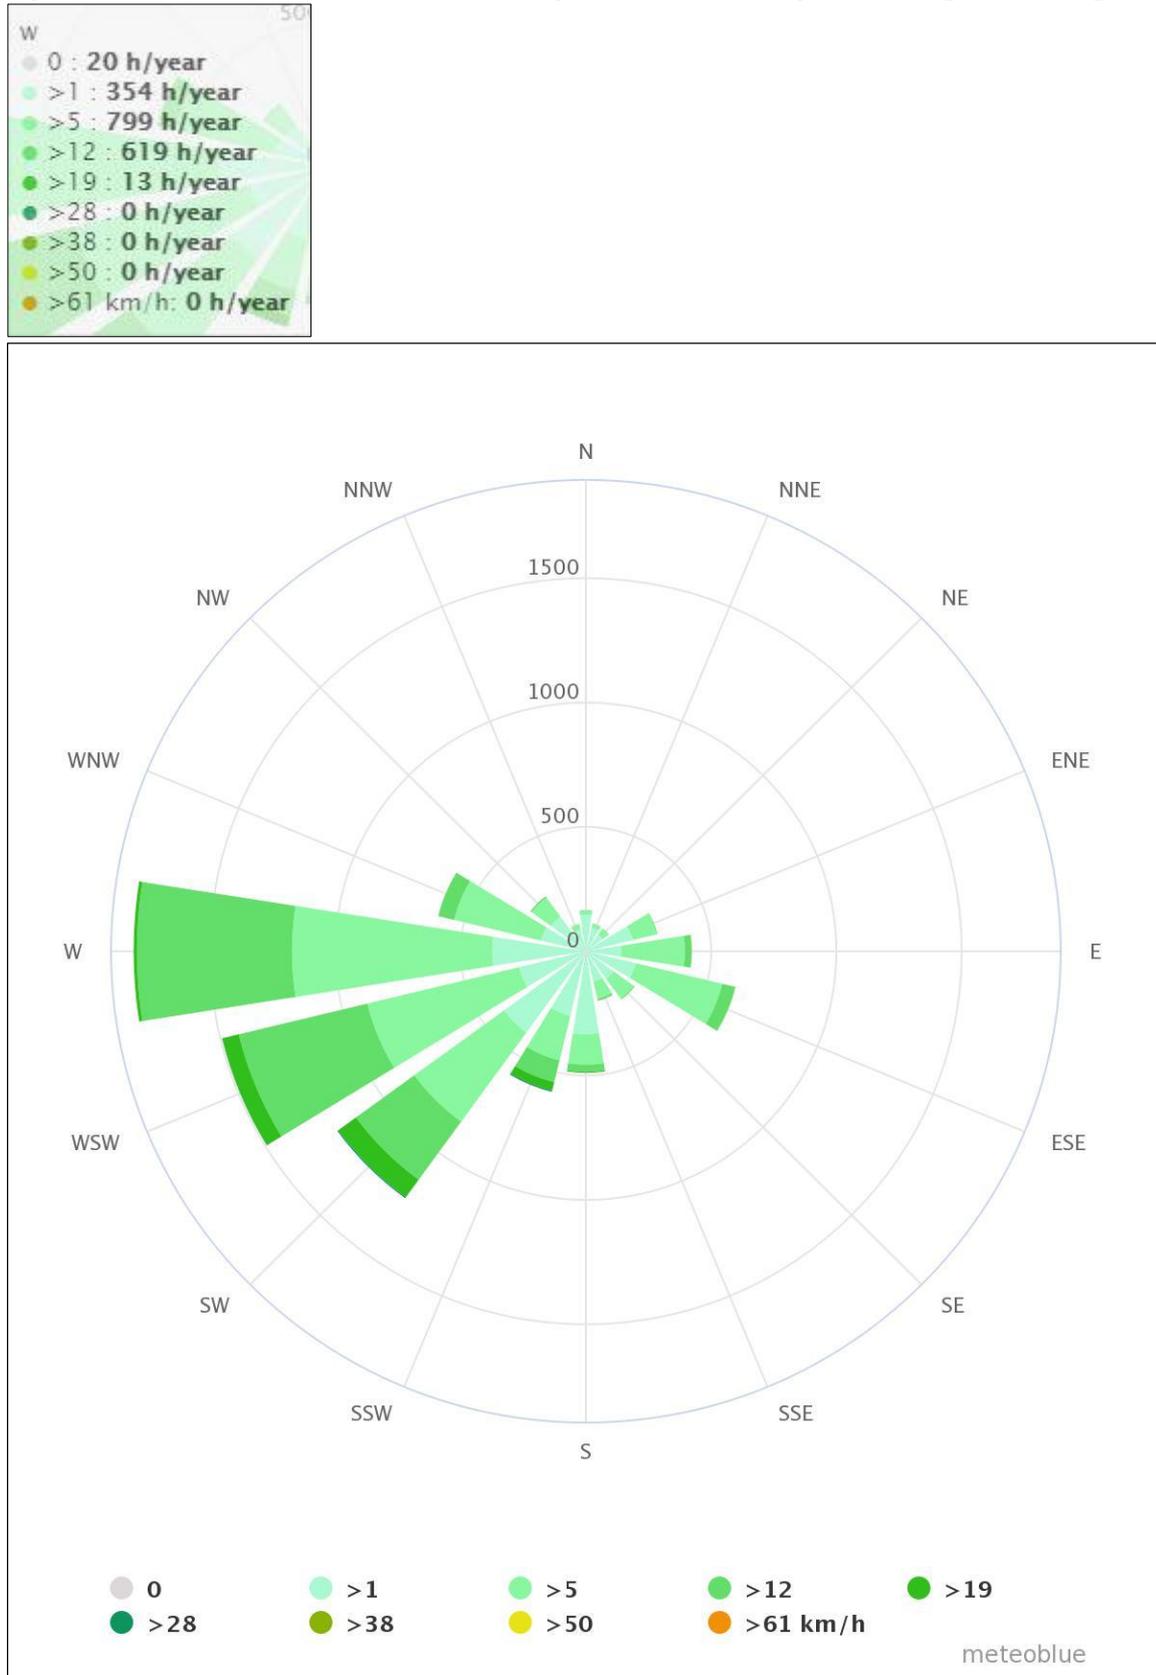
Figure Y Wind rose for Chouf caza area showing wind direction along with wind speed and frequency
